BMW Z4 Ignition Service

Purpose

This document describes the steps taken to repair a “misfire” diagnostic code on the Z4.

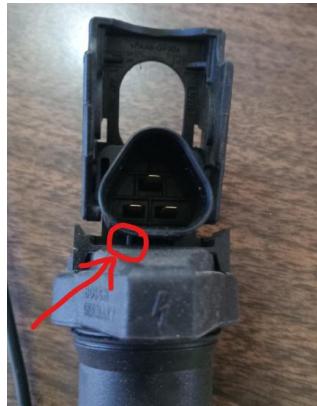
AutoZone originally sold me, what they “claimed” was an OEM drop-in replacement part (\$69.35.) However, when I got home and tried to install it, I ended up with almost an hour of frustration because I couldn’t get the wiring into the connector. I finally noticed that there was a small tab (see image below) on the left on the working coil, whereas the “drop-in replacement” I got from AutoZone had the tab in the middle of the connector. Since the mating connector has a ‘slot’ for the tab on the left, this explained why the center tab model wouldn’t work.

No doubt this tab is BMWs way of preventing you from using a non-compatible coil in your car.

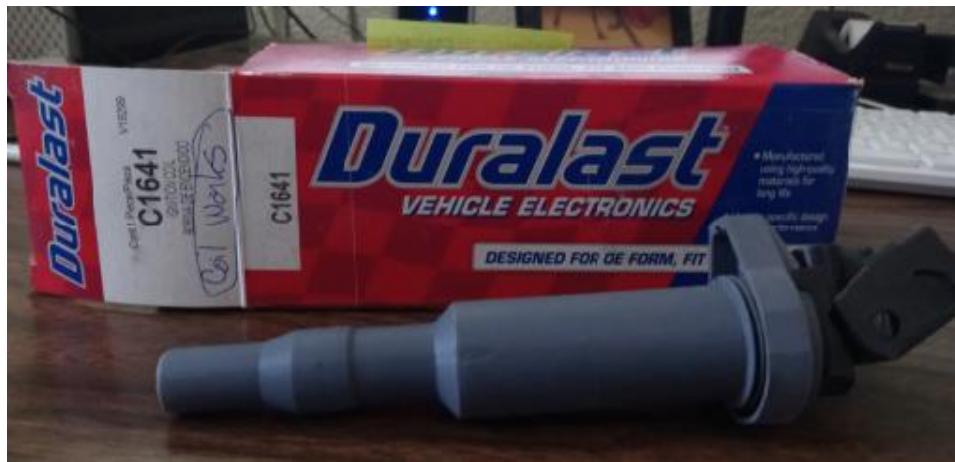
After returning “not really drop-in replacement” part to AutoZone, I had to settle for an aftermarket part so I bought the Duralast equivalent that was rated for the Z4 (\$50.93) and had “NO” tab – so it would fit in all models.

This actually worked fine and got the car running again; however, I was now uncomfortable using this as it was probably not really 100% compatible, and I’d rather have OEM parts, and it was probably time to replace all of the plugs/coils anyway.

When the kit arrived, I found out (much to my chagrin) that the Duralast coil I'd used was almost impossible to get out of the cylinder head. I literally had to climb into the engine compartment and pull it with every ounce of strength – I almost couldn't get it out. This was because the Duralast part had a slightly larger flare on the bottom than the OEM part. So, while it was (maybe?) electrically equivalent, it was not mechanically so. Moral of the story – stick to OEM parts.
