Window Heat Issues

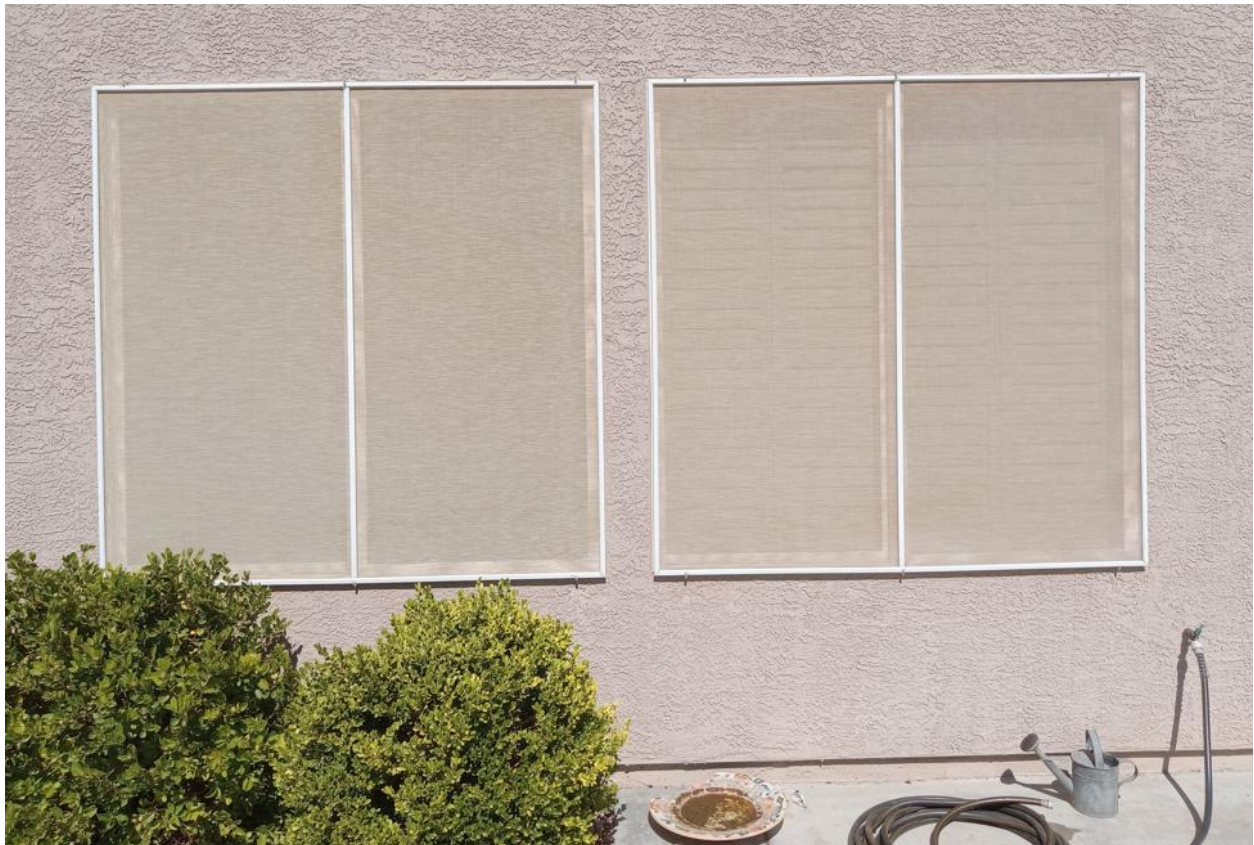
By chance I happened to check the temperature around the inside window frames in the bed room that was causing the AC to run longer – image below. Much to my surprise, the upper inside part of the window frame registered at 89F! And this was around noon in a room set to 74F with double pane windows, closed plantation shutters, and solar screens when the outside temperature was 100F.

These windows face eastwards and receive the morning sun. Similar windows under similar conditions (also facing east) but under a porch roof, only registered at 81F.

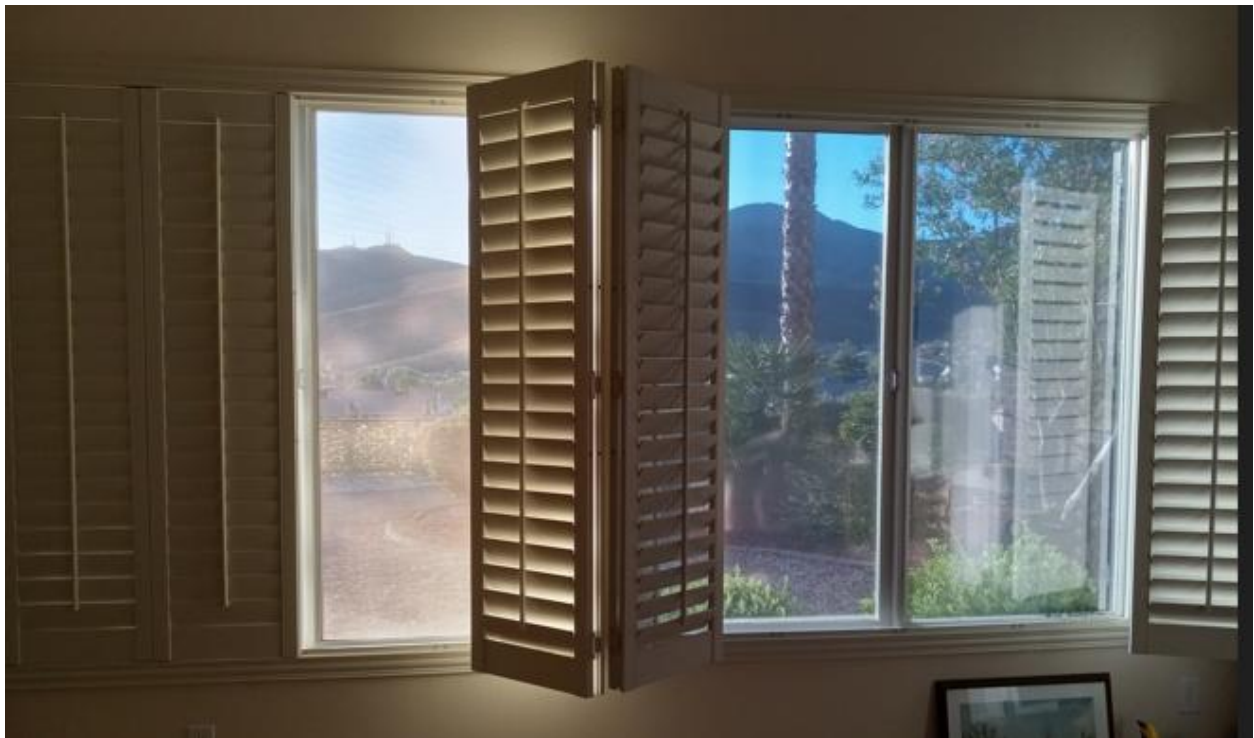
As can be seen, it looks nicer, and reduces the glare of the sun.

The following window film [Amazon.com: Filmgoo Window Privacy Film One Way Daytime Mirror Tint Treatments UV Heat Control Vinyl Stickers Sun Block Glass Paper Door Covering Reflective 35.4 Inch x 13.1 Feet Black Silver : Home & Kitchen](https://www.amazon.com/Filmgoo-Winodow-Privacy-Film-One-Way-Daytime-Mirror-Tint-Treatments-UV-Heat-Control-Vinyl-Stickers-Sun-Block-Glass-Paper-Door-Covering-Reflective-35.4-Inch-x-13.1-Foot-Black-Silver-Home-Kitchen/dp/B078383838) claims to block 97% of UV rays. I ordered one roll and applied it to the right side window.

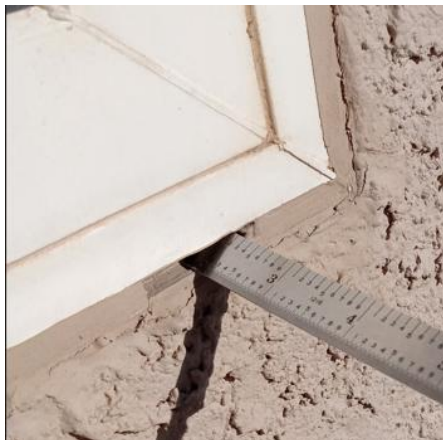
The window referred to as window “2” in these tests has a large gap (~ 1”) in the exterior caulking as shown below (in position “2A”.) This gap extends almost 2.5” into the wall. I fixed the gap after the tests – not wanting to confuse the tests by altering the conditions.

This could go a long way to explaining why “2A” temperature readings are a few degrees higher than “2C” readings in the UV film tests when the solar screen was removed from window “2” (the solar screen covers this hole when it is mounted.)

IMPORTANT – I later realized that this hole is a functional part of the window and should **NOT** be blocked. All of the windows have this hole and it is referred to as a “weep hole.” For more information see: [How To: Test the Weep System on Your Milgard® Vinyl Windows and Doors | Milgard](#)

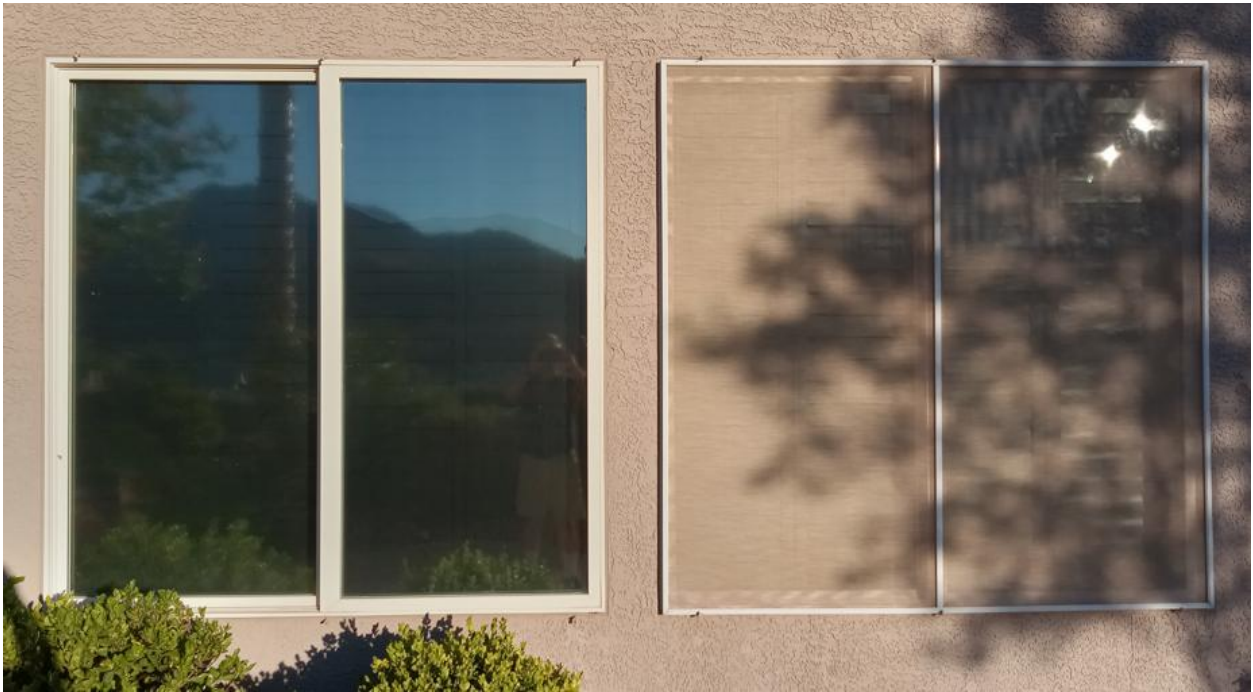
As can be seen in the picture taken 7/9/2022 @ 6:32am, window “1” is partially shaded by one of the back yard trees. This accounts for early morning temperatures being lower on the “A” side of window “1”.

The shadow only covers about 10% of the window in the bottom right by 7:00am and is completely gone by 7:20am (07/10/2020.)
