8080 Project

7601900 Board

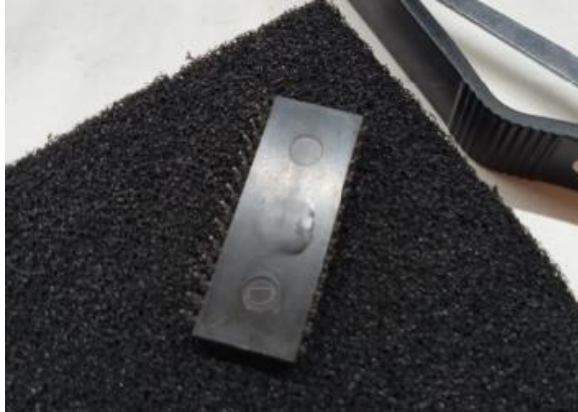
However, when I went to test the 8228 Bus Driver that I had, it did not work. In fact, it caused the 8080A signals to be distorted. After a bit of troubleshooting, I realized that the 8228 had an internal short. The chip would get hot, and when I eventually took it out and looked at the bottom it was very apparent that it was toast. You can see the packaging developed a 'blister' in the image below.

Unfortunately, I only had one of the 8228 chips. I was able to order more but it will be a week or two before they arrive.

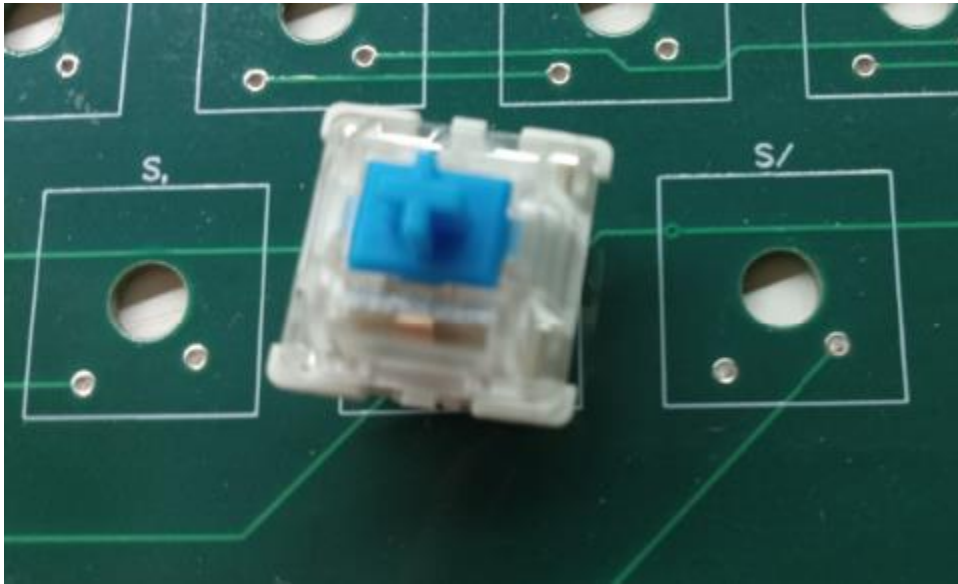
I then moved on to the keyboard, only to find that, while I'd spent lots of time perfectly positioning each key, I completely got the key pattern wrong. As you can see below, the keys end up rotated and unable to be fully inserted! This was a disaster. I was thinking of doing cuts and jumpers to fix stuff I missed, but this made the board virtually unusable – so I had to do another PCB layout to fix this and a number of other small issues that I'd found.

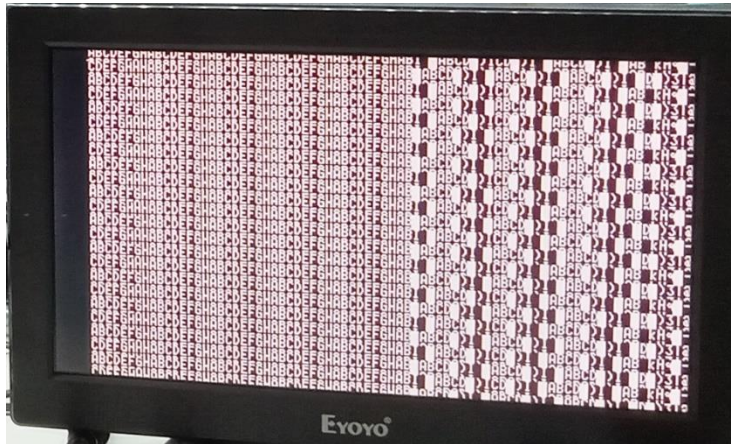
After hours of effort, I was able to get my software pseudo-DMA transfers to start working. You can see the alphabet string starting to show up on the left side of the screen. I was pretty happy at this point because I was finally able to get something to display.

After calming down a bit, I started to look into “why” only the first half of the line was being displayed on the left, and the right was still displaying garbage.

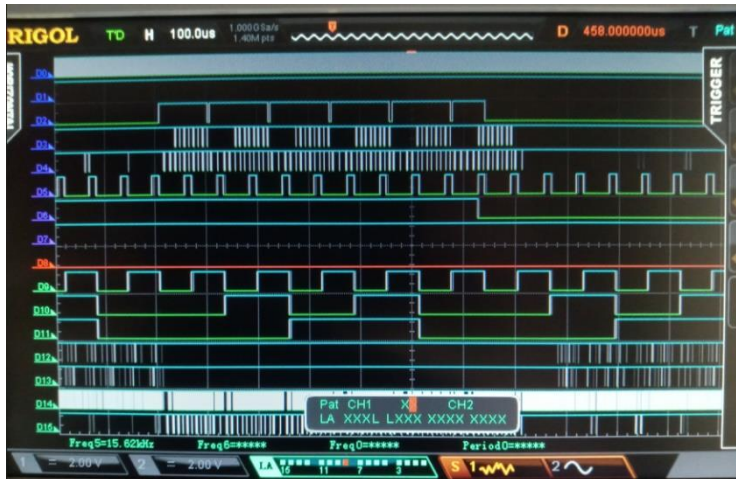
I tried various tricks, but in the end (as you can see below) I was forced to realize that the reason only the left side of the screen had valid data was because the pseudo-DMA logic was too slow and was only able to push out about 42 characters of data before the end of vertical refresh.

Because of this, the video chip aborted the DMA transfer (because it didn’t have enough data to display even one row.)

Looking at the pseudo-DMA logic, there was absolutely no way to speed it up enough to overcome this issue.

At this point I decided to design a DMA daughter board. This was cheaper and quicker than re-designing the entire PCB to add a DMA circuit, and I didn’t want to spend hours re-soldering all the parts on another board if I could avoid it.

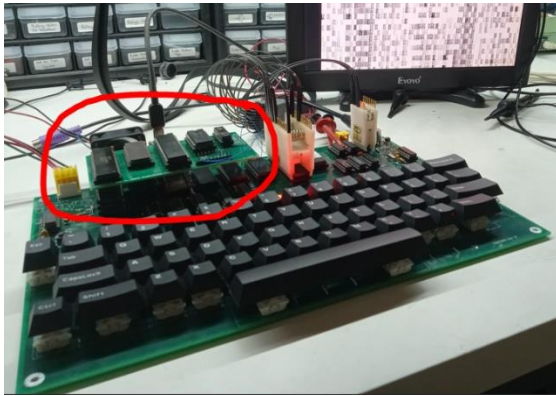
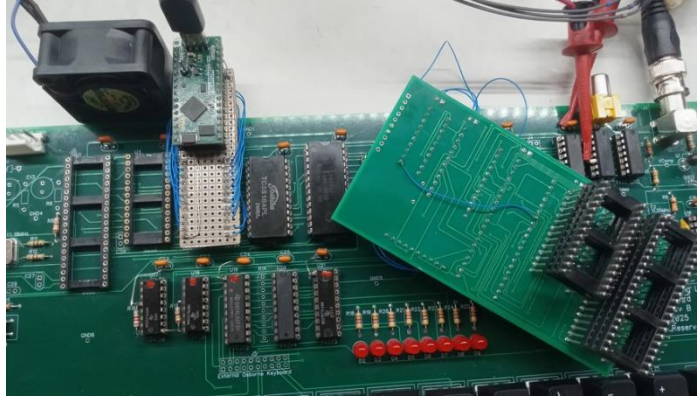
I received and built the DMA daughter board (see below left.) Unfortunately, I didn't think about all the

mechanical issues and found out the hard way that the PicoROM ROM emulator could no longer be used with the daughter board. I ended up having to hand build a small adapter board that would shift the EPROM socket out from underneath the daughter board so that the ROM emulator could still be used.

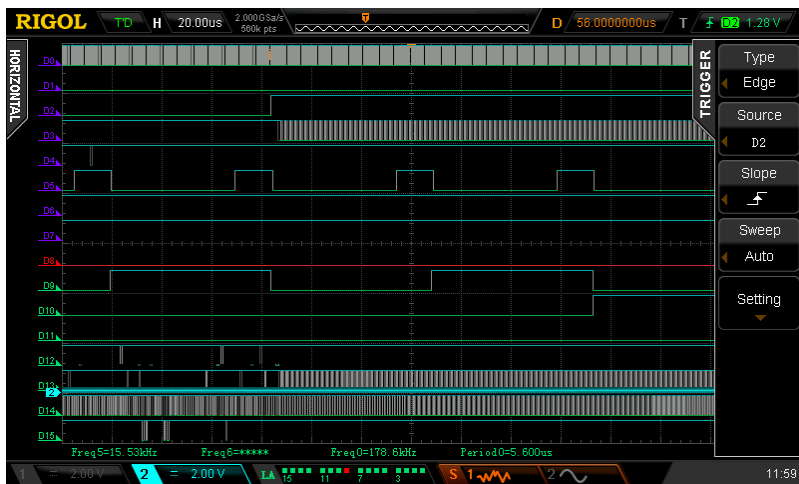
The DMA circuit was MUCH faster than the 8080 logic I had been using. You can see in the image below

that the DACK pulses are running 10-20 times faster than the software pseudo-DMA logic I had been using.

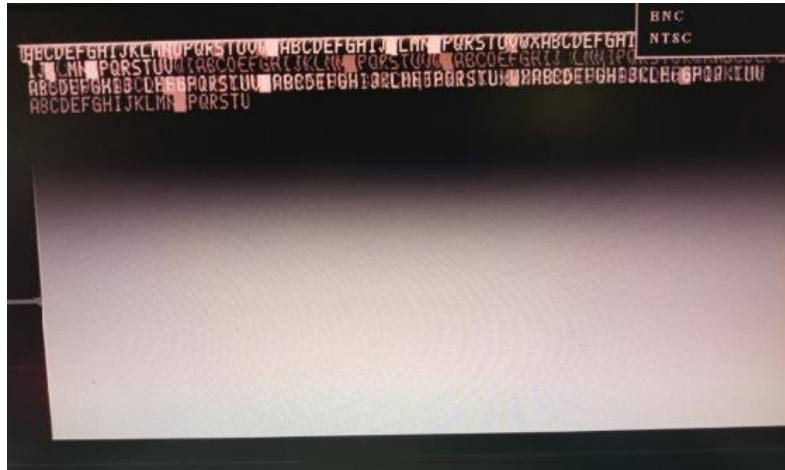
Below you can see sample video output. As can be seen, several characters are wrong, and the display is terminated prematurely on line 4 – there should be 24 lines of alphabet filling the entire screen.

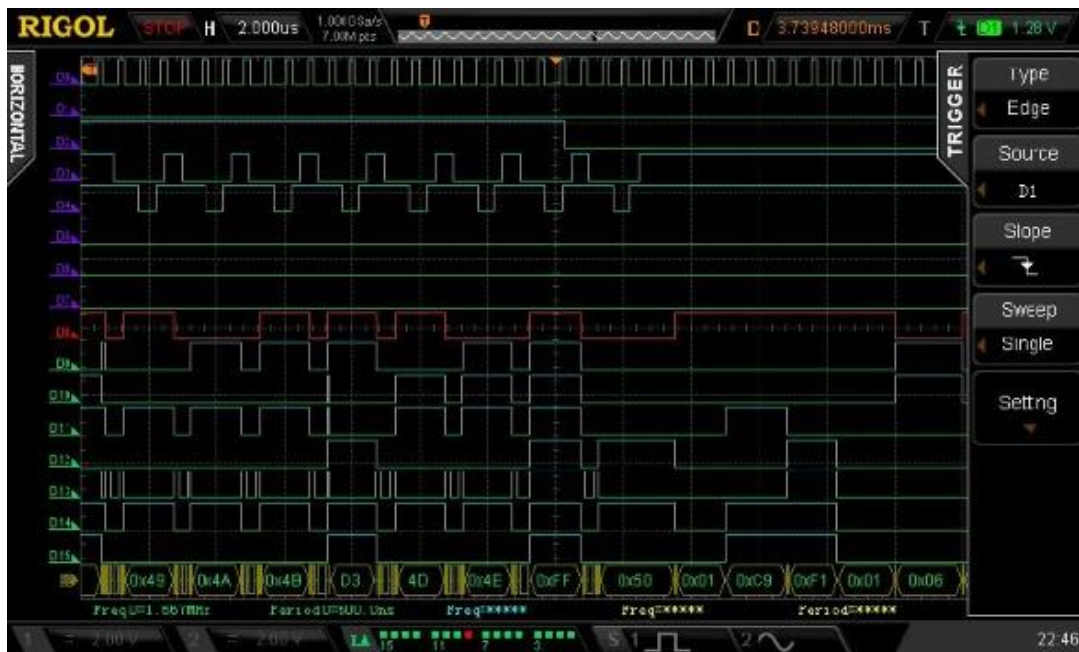
At the bottom you can see the actual data transferred by the DMA as: 0x49, 0x4a, 0x4b, 0xd3, 0x4d, 0x4e, and 0xff. Referring to the 8275 video chip spec, you will see that 0xff (technically 0xf3 – but apparently d2-d3 are don't care bits) is a special code that is interpreted to end the screen display and abort the DMA transfer.

So, it is not that the DMA is failing in some way, but rather that the DMA transfer is being intentionally aborted by the 8275 video chip.

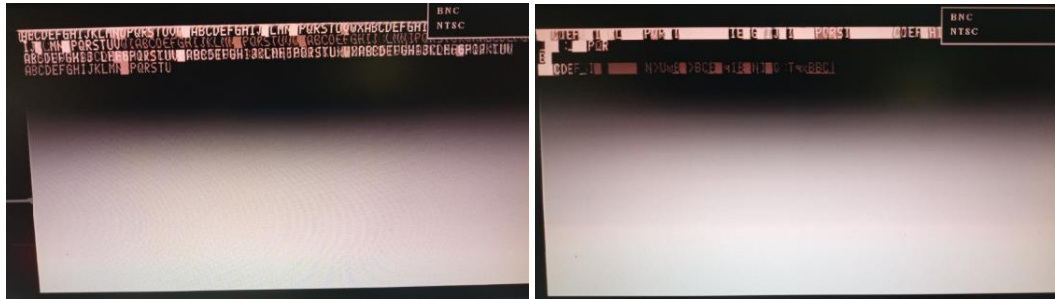
So, I tried disconnecting CS2 from the chip select logic and tying it to ground. You can see the results below. On the left is the result of both chip selects tied together (with most correct characters), and the right shows the result of CS2 tied to ground (with mostly wrong characters.)

This seems to contradict the spec, as I would have expected the results to be “better” in the right image (not worse.) But it does prove that altering the RAM access times does indeed have an effect on the DMA data transferred.

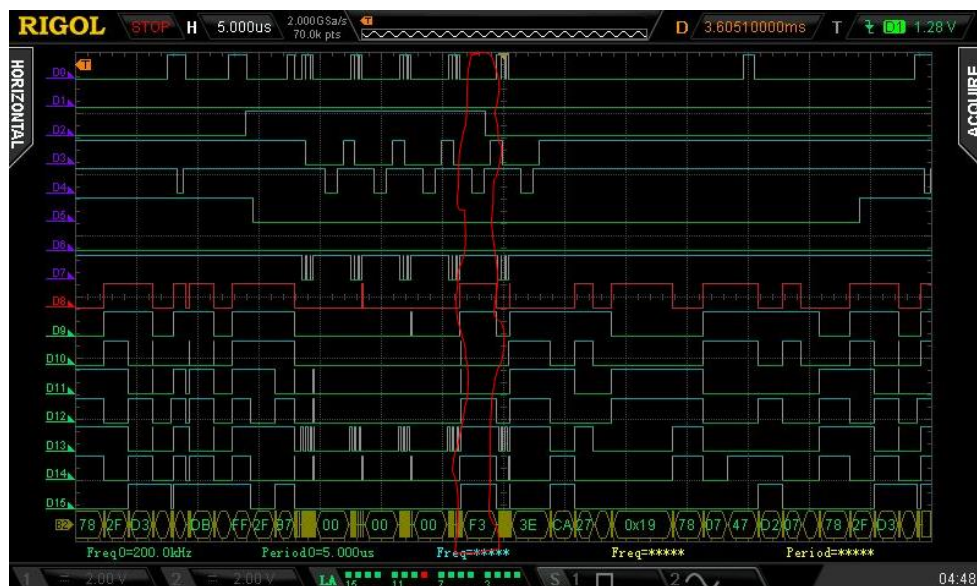
After altering the logic analyzer to include ROM CS on D0 and RAM CS on D7 it can plainly be seen that this is the case – the DMA is transferring from ROM for some reason.

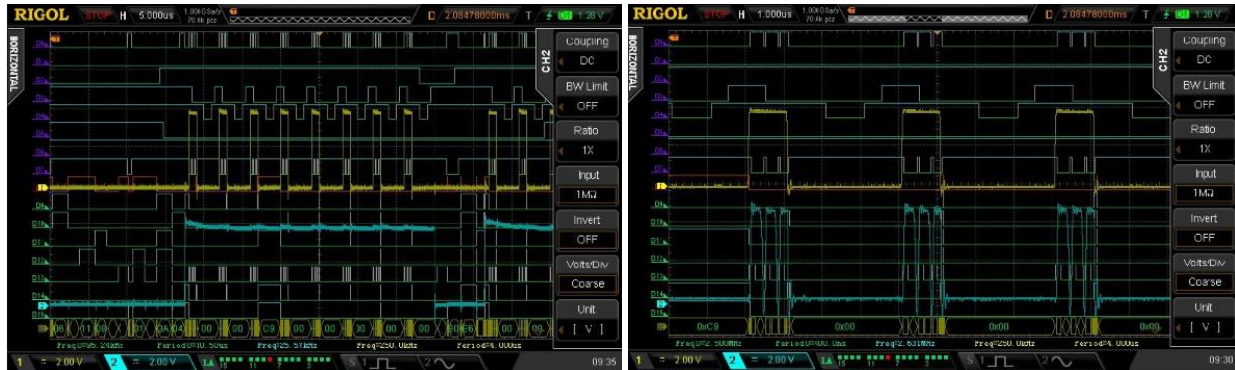
I was able to capture states of the DMA and 8212 I/O Port below. The image on the left shows an 8-byte DMA transfer with DMA ADSTB (yellow) and AEN (blue) on top of the logic analyzer data. The image on the right shows the same – zoomed in a bit - but with DMA ADSTB (yellow) and A13 (blue.)

The right image clearly shows A13 low while D3 (DMA DACK) and D4 (IOWR) are both low. This explains why the DMA data is coming from the ROM and not the RAM.

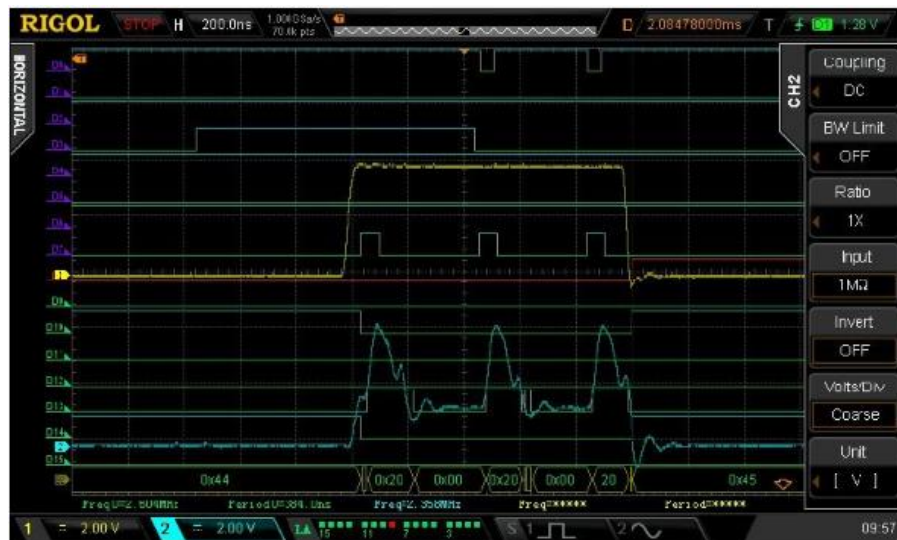
I then captured the same region, except this time instead of looking at the output of the 8212 for A13, I looked at the input – which is the D5 data line which you can see below in blue.

The D5 data line looks horrible and has a very slow rise time compared to the ADSTB above it. It is for this reason that the latch is latching a value of '0' for A13, instead of '1' which would be registered if the D5 data line had a better rise time and cleaner signal.

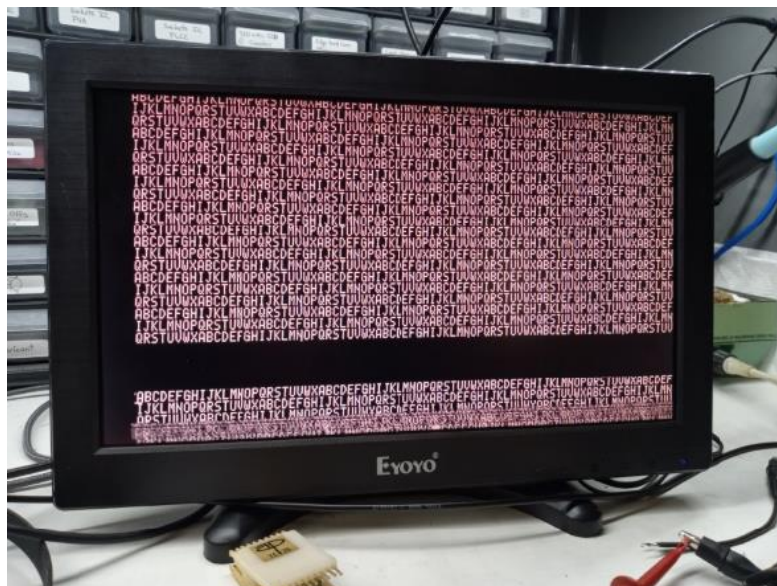
You can now see below that, not only is the monitor displaying all of the correct characters, but additionally all of the jitter that used to be present is gone and the display looks rock solid.

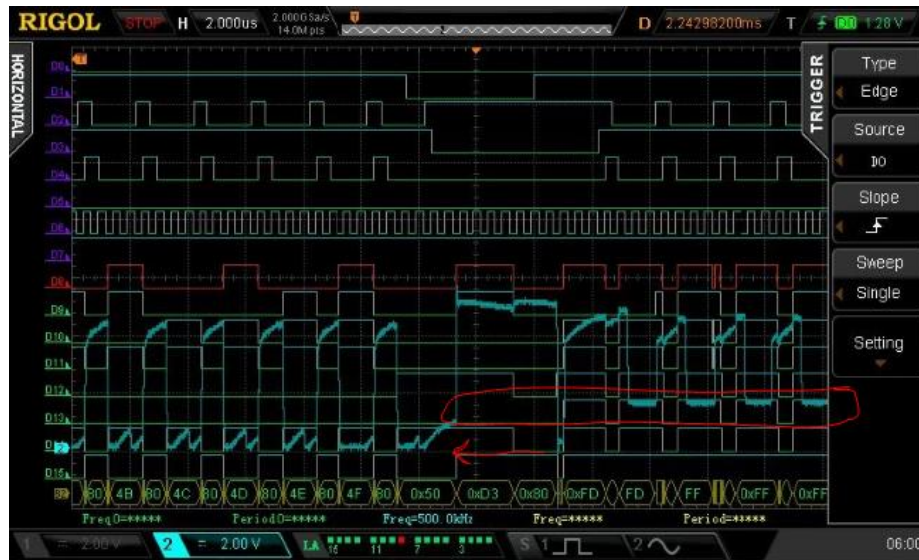
The left side of the screen shot shows correct operation (see 4B, 4C 4D... in bottom showing valid ASCII alphabet characters) vs the right side showing the error state (see FD, FF... characters showing abort DMA xfer commands.)

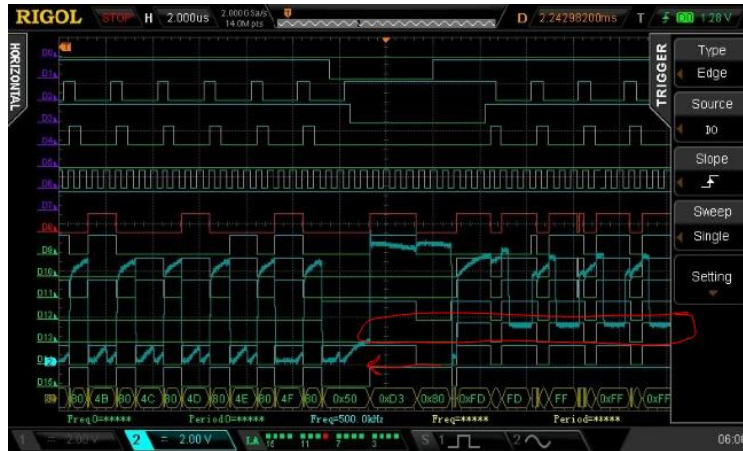
The screen shot above clearly shows what is likely to be bus contention. It couldn't be the peripherals, as I had made the enable logic immune to DMA transfers, so it had to be something else.

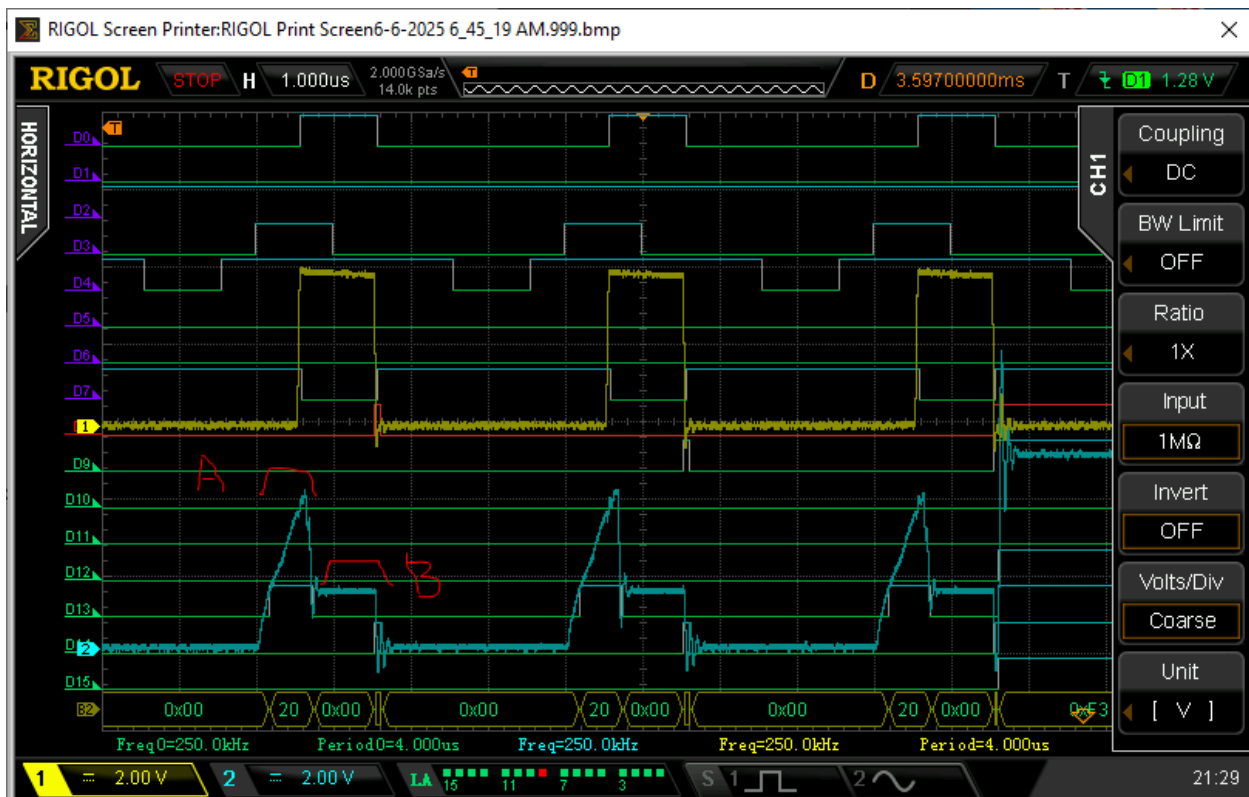
This is, in fact, the problem I was experiencing. Adding the pull-up resistor will only work in my very specific case where the RAM transfer address is in the 0x2xxx range. You can see this below – the yellow scope line is ASTB, and the blue is D5 from the DMA chip.

You can see in section 'A' adding the pull-up resistor "fixed" the problem by pulling up the floating data bus so that the value can be correctly read by the 8212 on the rising edge of ASTB. You can then see in section 'B' where the DMA actually starts driving the data bus (in this case D5) to a value of '1' so that it is stable before the falling edge of ASTB.

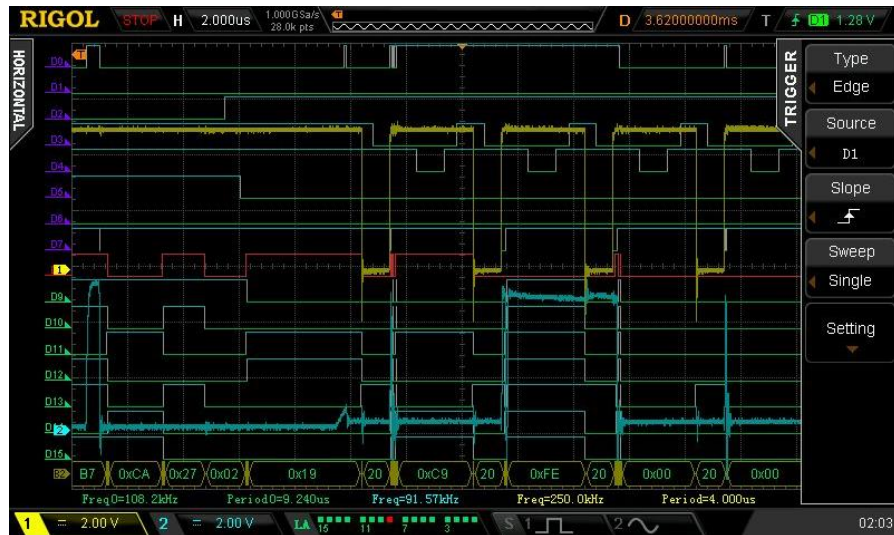
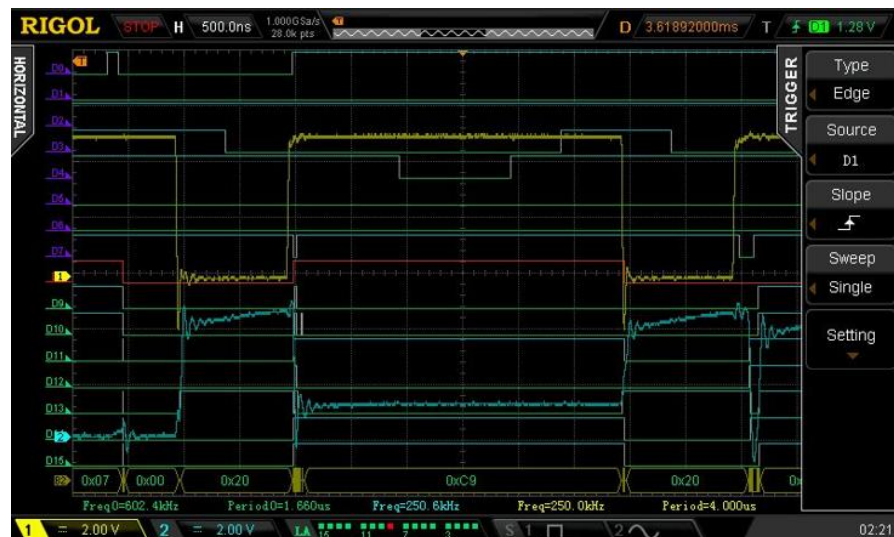
As you can see, the results don't look any better which is rather confusing.

I spent the time to modify the circuit to invert the DMA ASTB signal (yellow is inverted ASTB, blue is D5 8212 latch output or A13) on its way to the 8212 latch. You can see the results below.

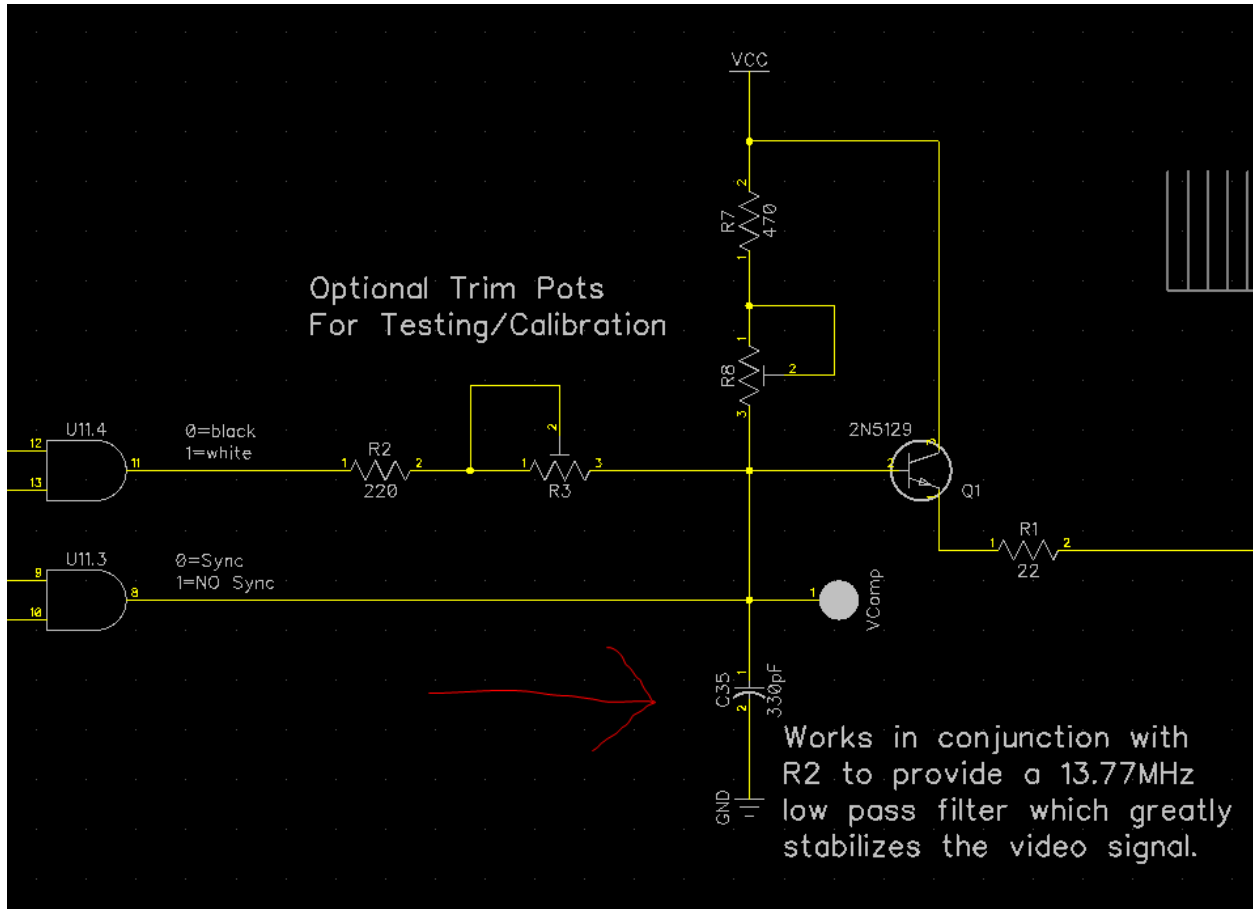
I finally found that this was due mainly to high frequency noise on the video signal.

This was solved by adding a 330pF cap as shown below in the video output section.
