## How to Fix Culligan Water Softener Leaks

Your Culligan water softener will probably give you years of reliable service, but eventually it will wear out and start leaking. Of course, there can be many sources of leaks but the most common is around the plunger shaft that moves every day in the control unit. This document describes the simple procedure to resolve this.

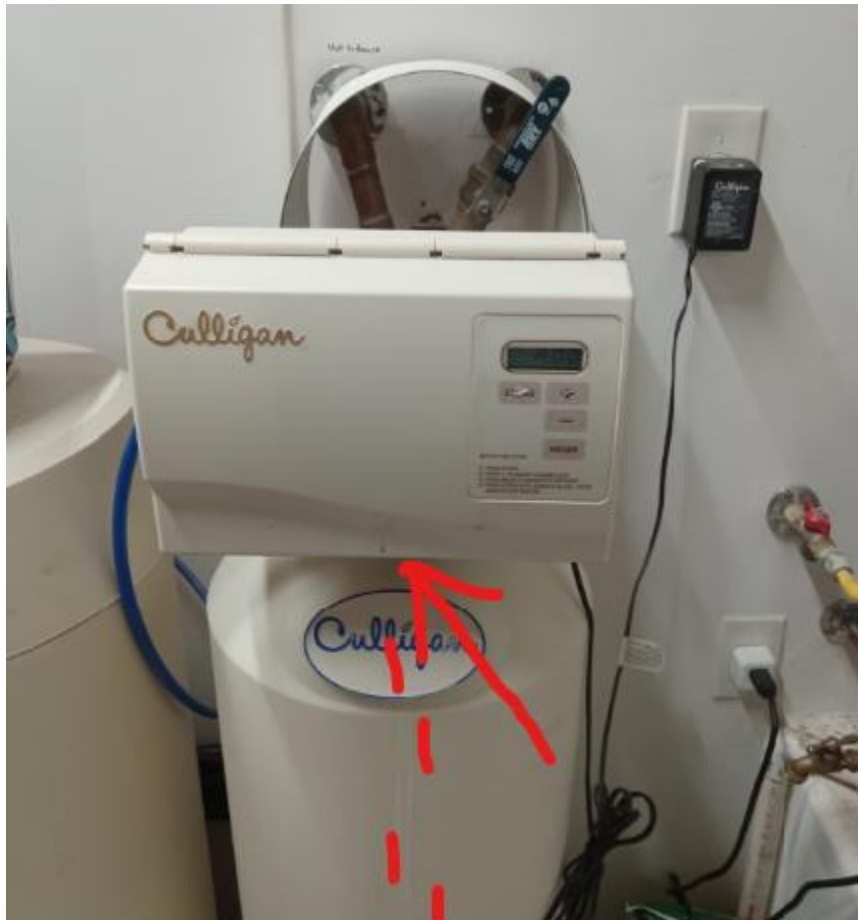
You will most likely see water dripping down the front of the unit – as shown in the picture below.

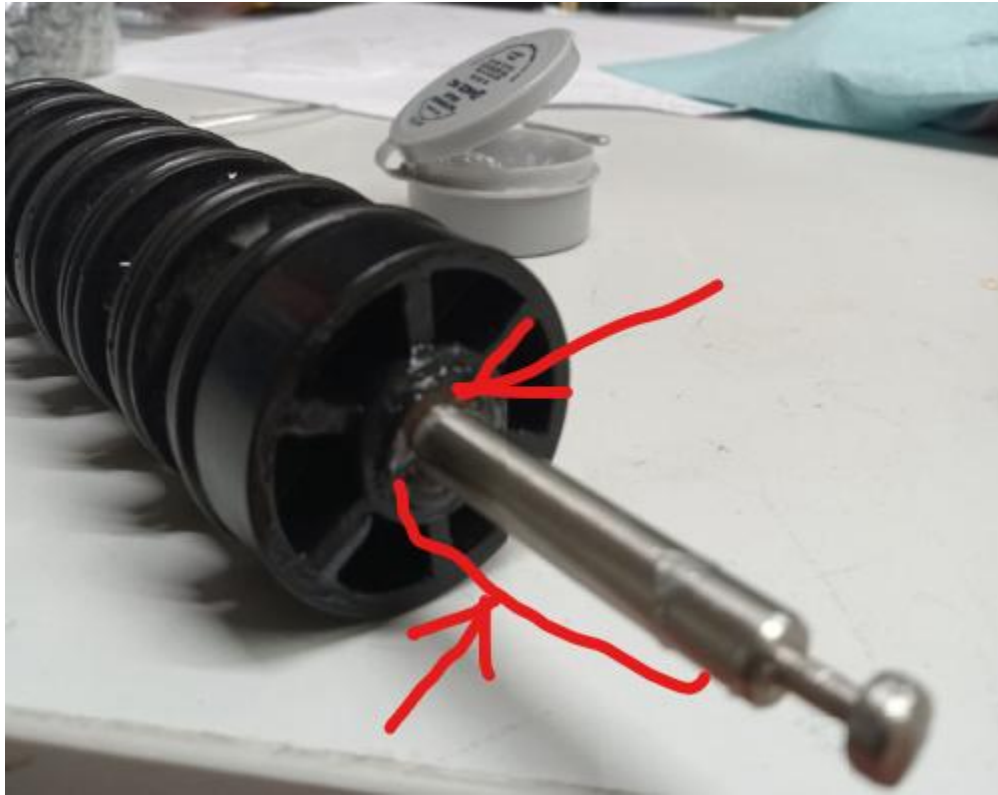
After replacing the o-rings, I still had a minor leak. Putting grease on the moving shaft resolved this. I suspect that this may have to be repeated periodically.

Then you must apply a liberal amount of silicone grease to the metal shaft and the inside of the black plastic sleeve where the shaft slides as shown below.

Make sure that you get the grease fully applied to all of the moving surfaces.
