# Jeep Find Evap Leak

## Background

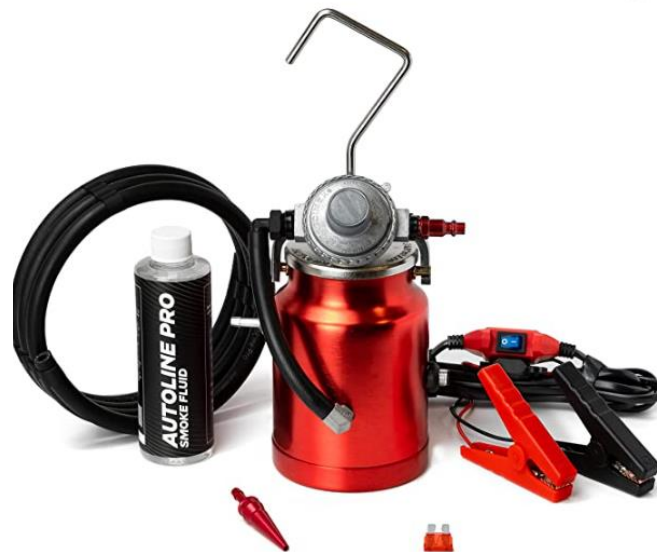
I finally broke down and purchased a smoke test tool to identify the issue. There are many available but I chose this one on Amazon because it was reasonably priced, made in the USA and had good reviews.

[Amazon.com: AutoLine Pro Automotive Smoke Machine Leak Detector EVAP Vacuum Diagnostic Tester | Shop Series | Made in The USA : Automotive](#)

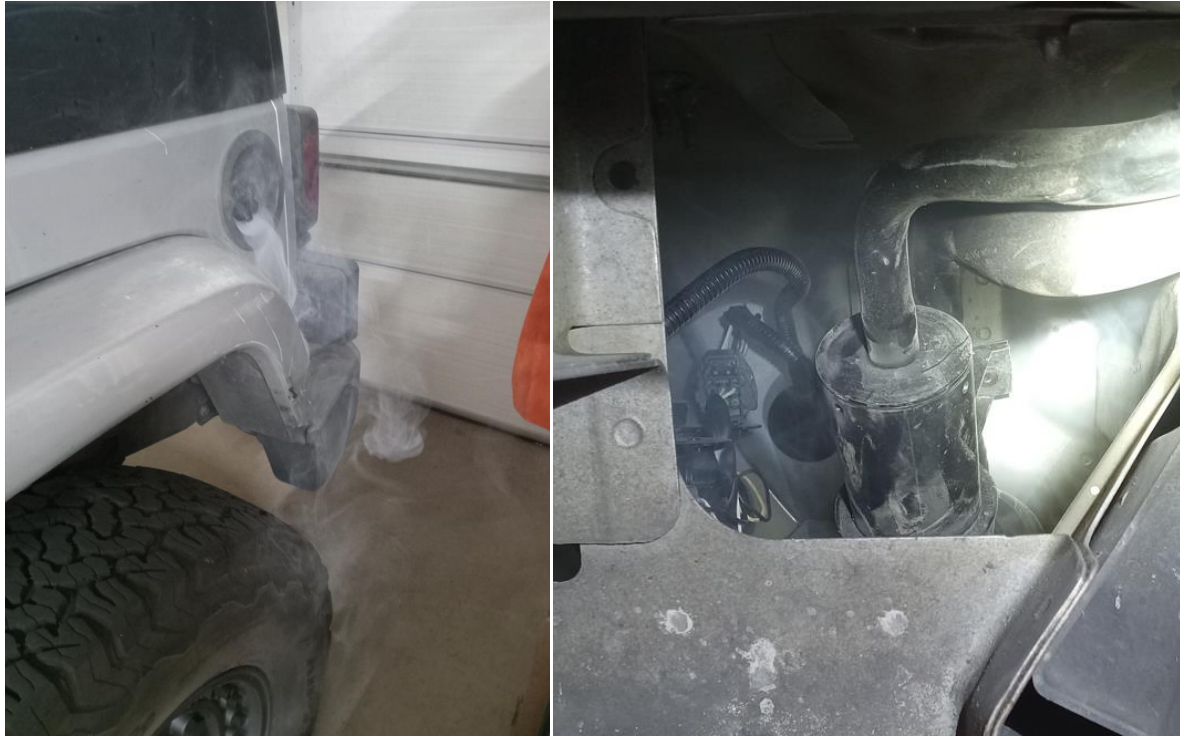
Once you turn it on, it will start pumping thick smoke into the evap system. I then went under the vehicle and spent several minutes looking around but couldn't find any leaks on any of the evap hoses or components. I was kind of frustrated - because clearly there was an evap leak - so I got back up from under the vehicle and immediately noticed a huge cloud of smoke billowing out of the gas cap area (photo on the left)!

Further investigation also showed a much smaller smoke leak from the evap air intake filter (photo on the right - take from underneath looking up at the inside of the gas filler tube.)

Clearly this was the cause of the evap leak!

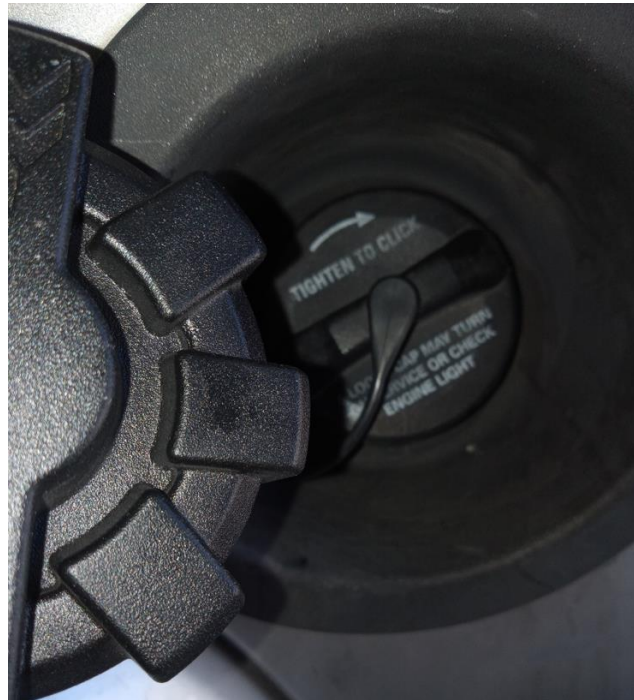
This is one of the most common causes of evap leak issues on a Jeep as you will see in all the forum discussions. I doubted that this was my issue because I had replaced my original cheap gas cap with a really fancy and expensive billet cap – but, though it looked nice, it failed to produce a good seal even with some silicone grease applied to the gasket.

So I dug around and found my old Jeep gas cap and put it back in. This immediately fixed the problem. You can see in the photo below: the fancy but leaking gas cap on the left, and the old working gas cap on the right.

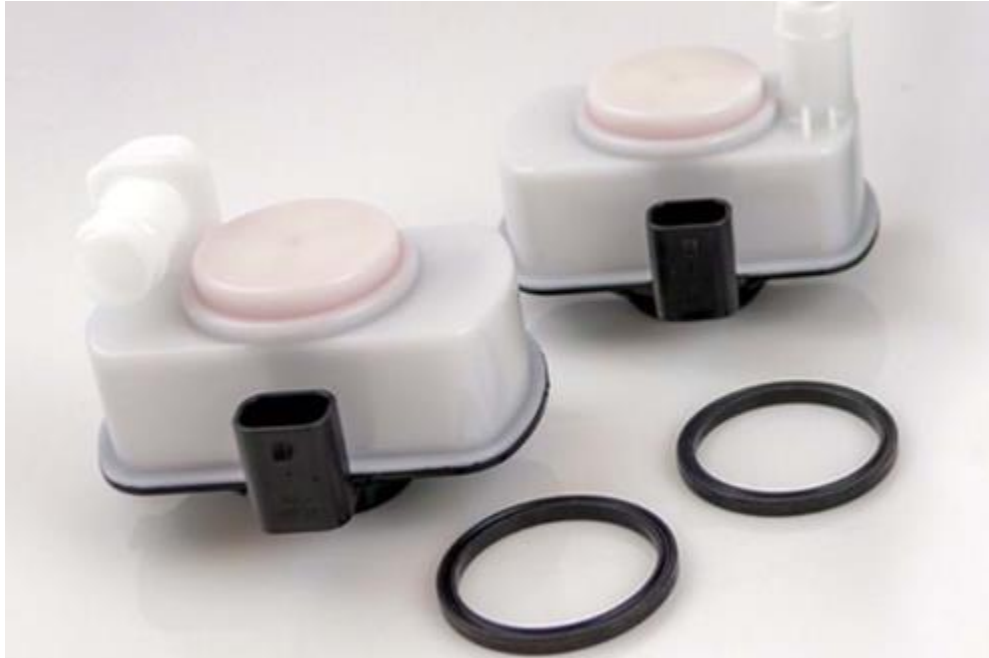
The evap air intake filter is connected to the Evap System Integrity Module (ESIM) underneath the vehicle. The ESIM normally only opens when the engine is running and the system is venting the trapped gas vapor into the intake manifold. For the ESIM to be opening when the engine is off is most likely caused by a faulty ESIM. I have this on order and will replace it shortly. It is noteworthy that this is the same module that the dealer replaced last time it brought it in for an evap leak problem.

This is a clever departure from the usual “evap pump” and “evap pressure sensor” combination found in most vehicles. For a full description of how this works, please refer to the following:

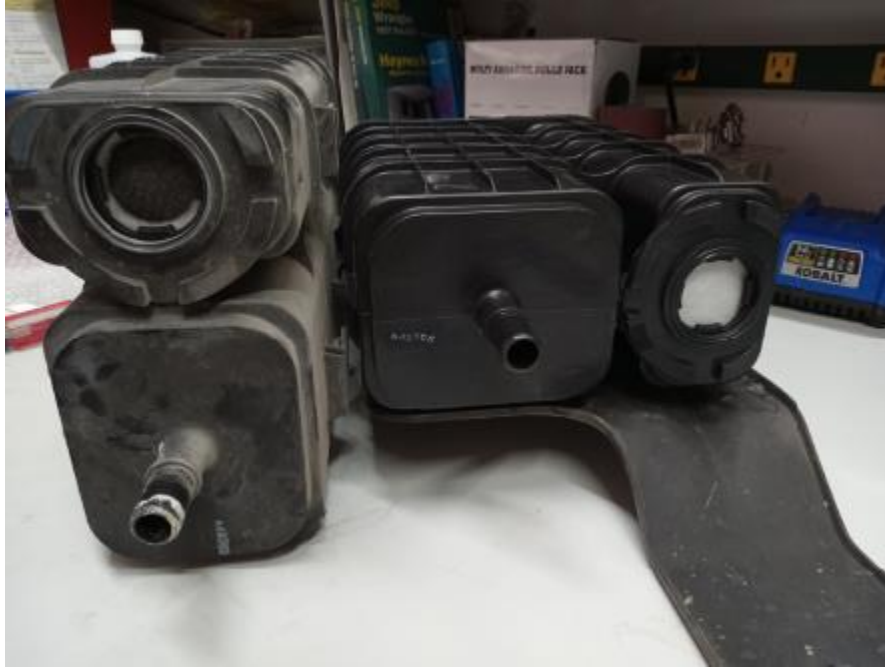
I had ordered the evap canister before finding the gas cap leak so I would be prepared in case it was leaking as well. When I removed the ESIM, I noticed that the inside of the canister had a solid black circle in the mating area. After I unpacked the new canister I realized that this was not normal, and that the old canister was full of crud. Note the difference in the photo below – left canister is the old one, right canister is the brand new one.

So I ended up replacing the canister as well. I test drove it for a few miles and there are no check engine lights anymore. If this holds out for a few weeks then I will feel confident that the problem has been solved.

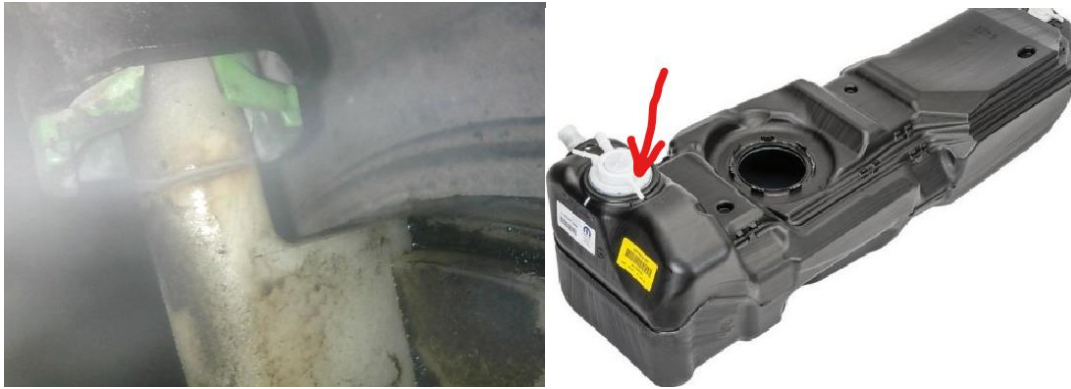
There turned out to be another leak on the top of the gas tank where the pipe was almost completely broken. It almost looked like someone had taken a saw and cut it almost (but not quite) all the way through. You can see the smoke escaping from the crack in the picture below.

At first, I tried just applying super glue around the cracked area, however this didn't work and the piece completely broke off when I tried to re-attach the hose after the glue dried.

My first attempt to solve this was to buy a new replacement part for the white plastic piece that was broken. After hours of searching, it became apparent that this part cannot be purchased separately and the only way to get a new one is to buy the entire gas tank which was more money and time than I wanted to spend on this problem.

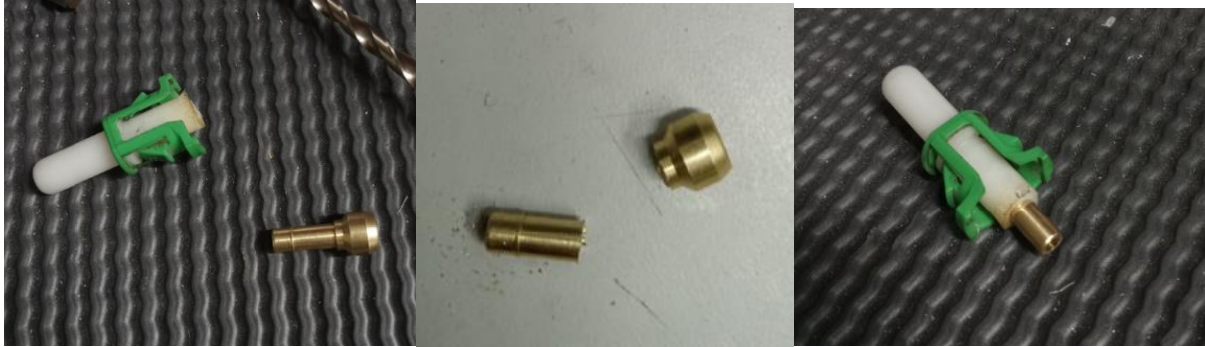
I was able to take a standard 1/4" poly tube barb adapter, remove the large end, and insert the remaining brass tube into the broken piece after drilling the hole slightly larger.

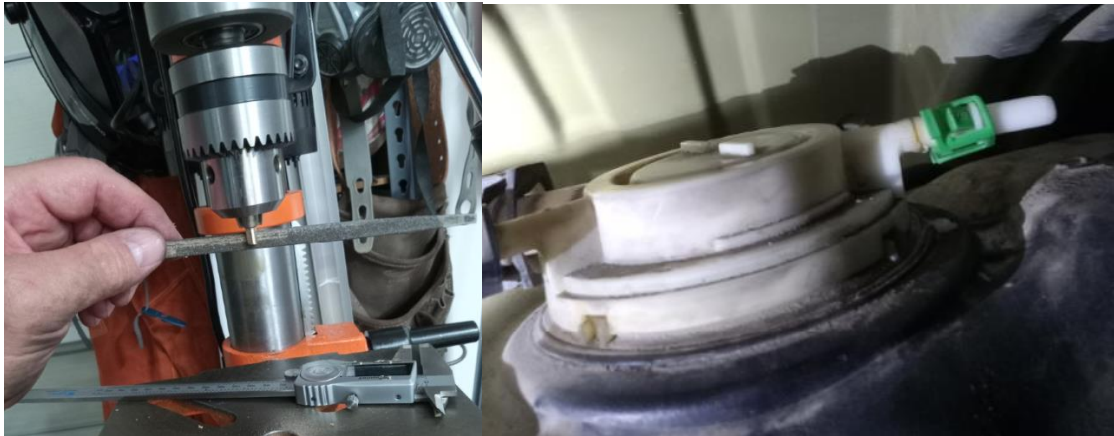
Sadly, I couldn't use the same simple technique to get it to go into the fuel tank because there was no room to get a drill into that area of the Jeep without dropping the fuel tank (a major job.)

So, I had to grind down the brass insert until it was small enough to fit into the existing hole in the top of the fuel tank. As I didn't have a lathe, I ended up putting it in my drill press and applying a file to the side until it was thin enough. I was then able to re-attach the broken piece to the gas tank using the modified brass tube. After super gluing the two pieces together, I was left with a very sturdy repair job.

This appears to have resolved the check engine light but, of course, I'll have to drive it for a while to see if there are any other leaks that pop up.

This last repair was June 2023. April 2024, after 10 months of no check engine lights, I took the Jeep for its annual smog check and passed with flying colors! So, the repairs were a success.
