Osborne I “Luggable” Computer

Here is another industry first that I’ve been lugging around for decades and finally decided to see if I could get it working again. This was the very first “laptop” computer and I still remember how exciting it was to be able to carry your computer around with you – no need to go to the gym after this!

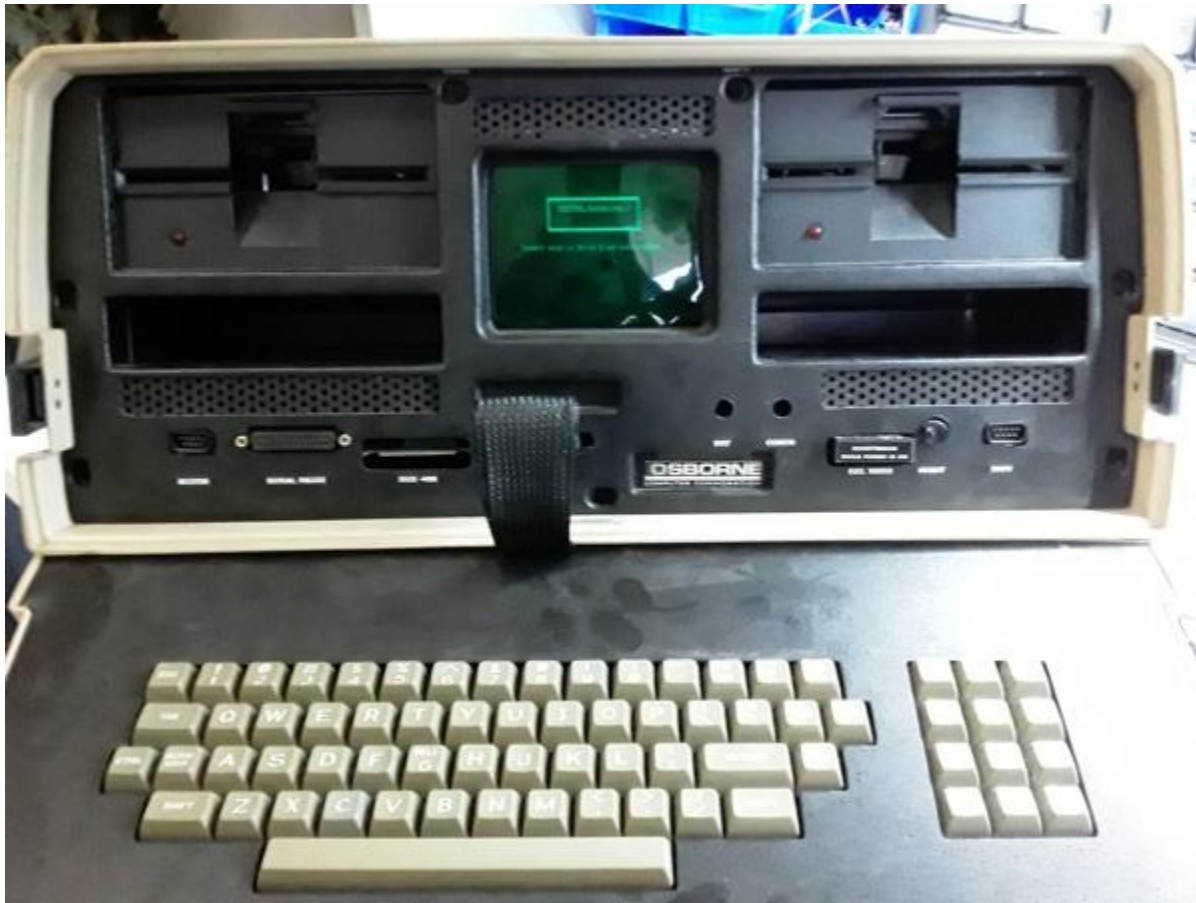
Turning on the old Osborne computer presented a screen prompting the user to press ‘return’ to boot from the floppy drive.

However, pressing the ‘return’ key did absolutely nothing.

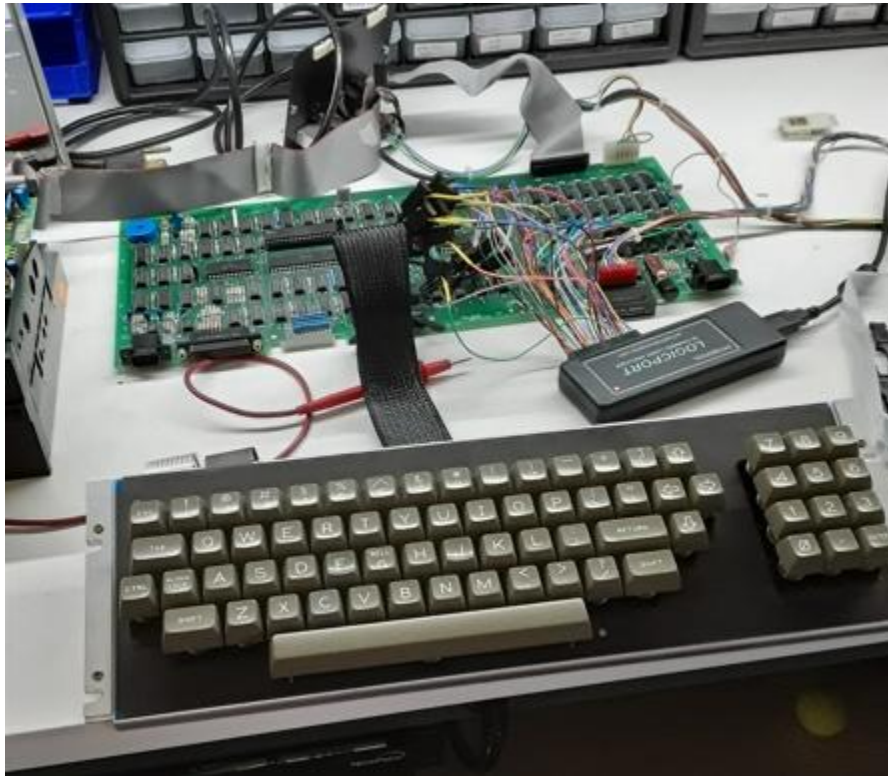
After stripping the computer down and hooking up a logic analyzer to the keyboard logic, I was able to ascertain that the row/column scan process was operating – indicating that the CPU was basically working and that the keyboard logic was more or less functional.

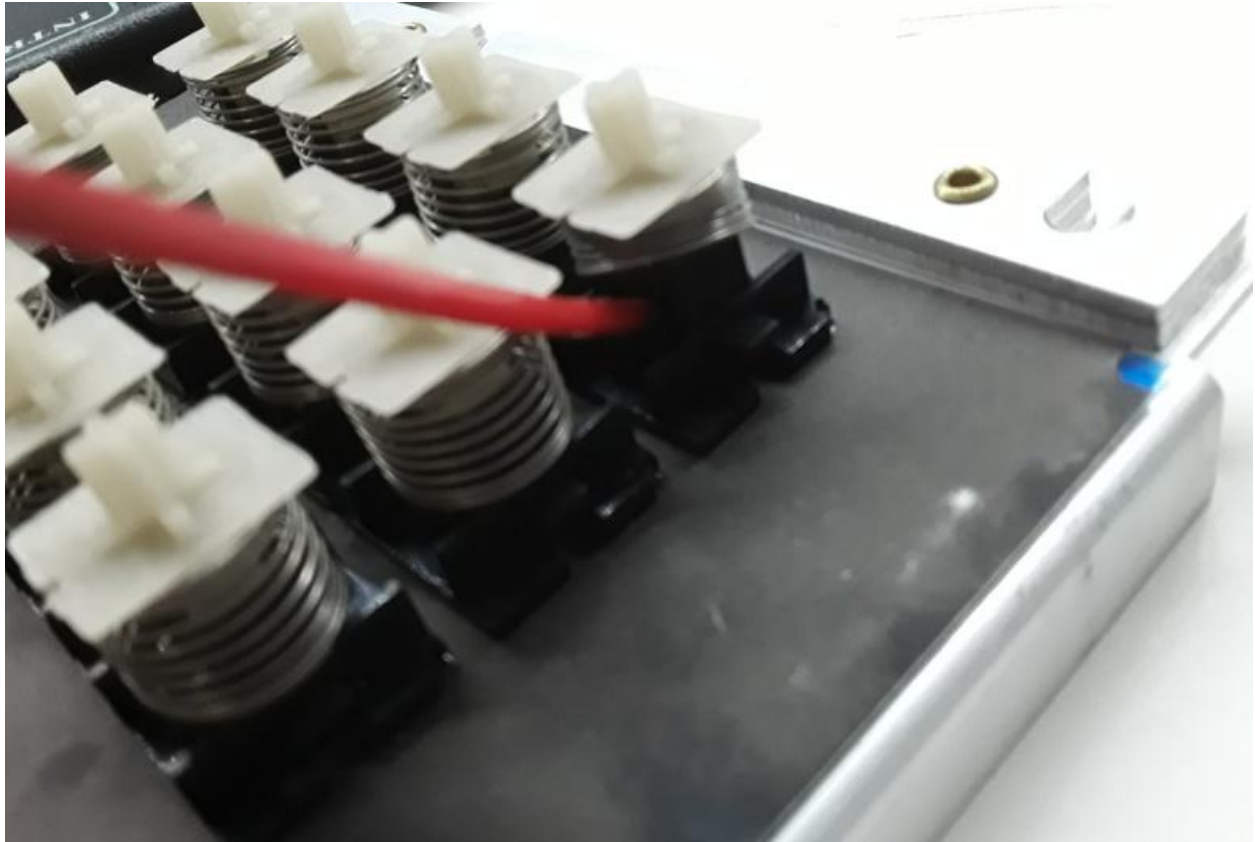
I then disassembled the keyboard to see if I could take the keys apart and possibly find some dirt stuck in one of the keys.

At first I couldn't figure out how to take the keys apart without breaking them. After reviewing some other comments on the internet it became clear that you just had to 'yank' the white plastic tops off. This worked fine and I was able to see 'inside' the switch, however I was not able to find any visible cause for the shorts.

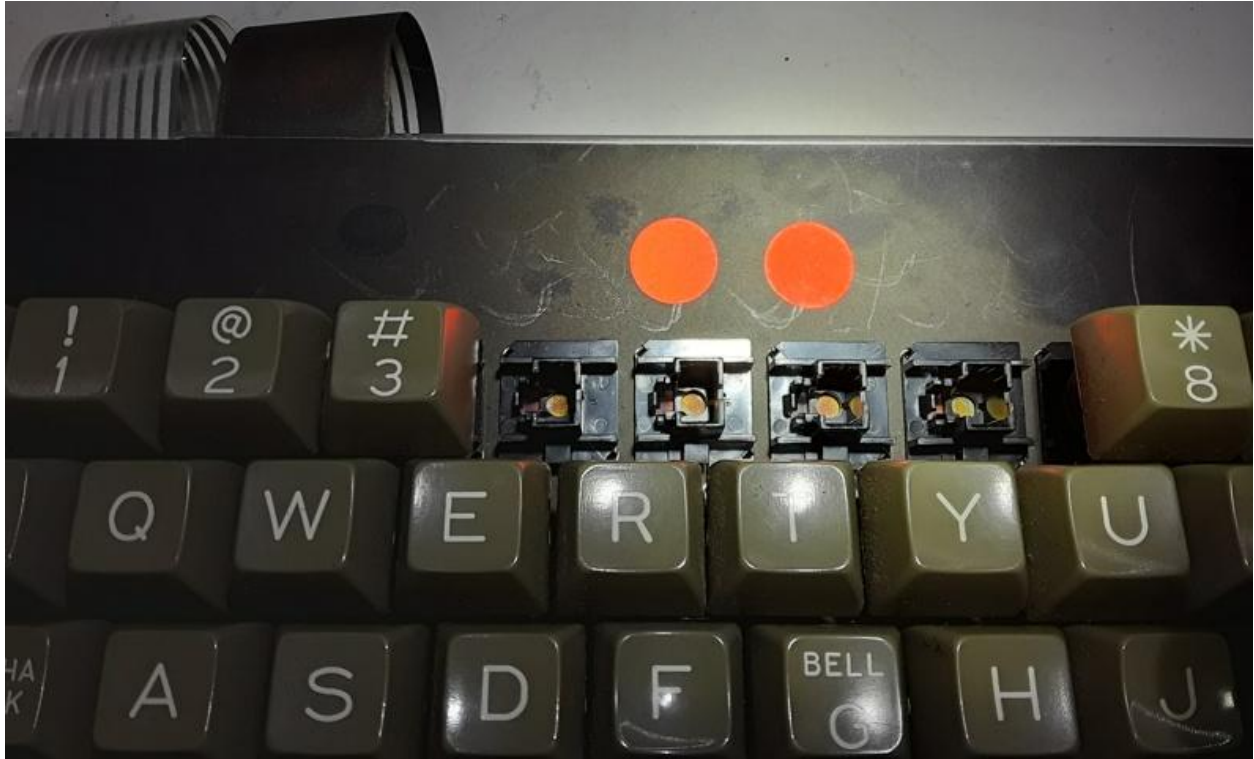
By hooking an ohm meter across the row/column lines that appeared to be shorted (i.e. it was reading about 17 ohms where the working lines were open circuits) and pressing the keys on these rows I was able to notice that only two keys affected the ohm reading when they were pressed – and these only slightly. This was the '5' and '6' keys.

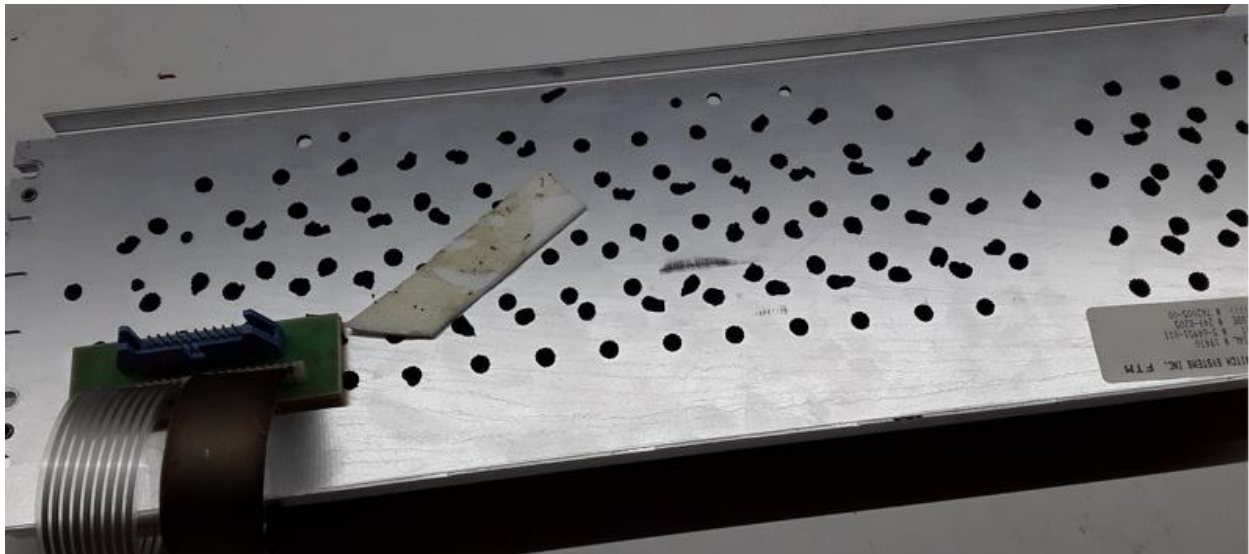
The difficulty in repairing this problem lay in the fact that the keyboard was not designed to be taken apart. Each of the plastic key housings had extrusions that when through holes in the keyboard chassis and had been 'melted' down to permanently attach them mechanically to the chassis.

To make things worse, the keys were simple 'plungers' that activated a membrane keyboard that was sandwiched between the plastic key housings and the metal back-plate. This means that all of the keys would need to be removed to get to the membrane in order to repair it. This appeared to be a daunting amount of work, and it would be questionable whether I would be able to securely re-attach the key housings because most of the extruded plastic would be lost in the removal process.

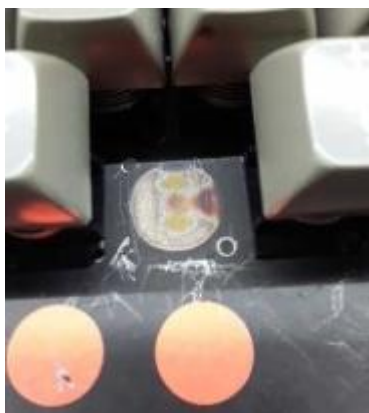
Eventually, after a lot of thinking about the best way to fix it, I decided to try and remove the two keys that seemed to be causing the problem and hope that there was an obvious fix once they were removed.

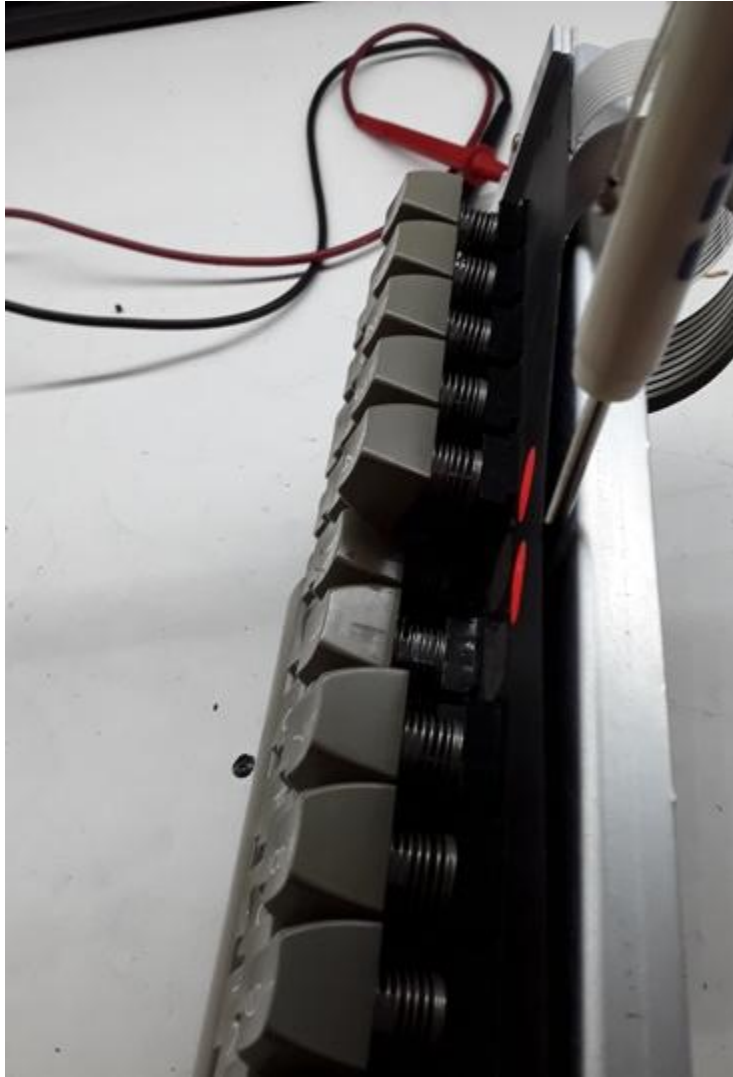
Once I had both keys removed, I could see no obvious problem and was starting to think the solution hopeless. At this point I pretty much stopped trying to be delicate and preserve everything because it seemed hopeless – this turned out to be a good thing.

I then simply 'jammed' a screwdriver between the two layers of the membrane keyboard and twisted it around where the contact points for the two questionable switches were located.

This did the trick! The membranes were able to separate and break the short condition.

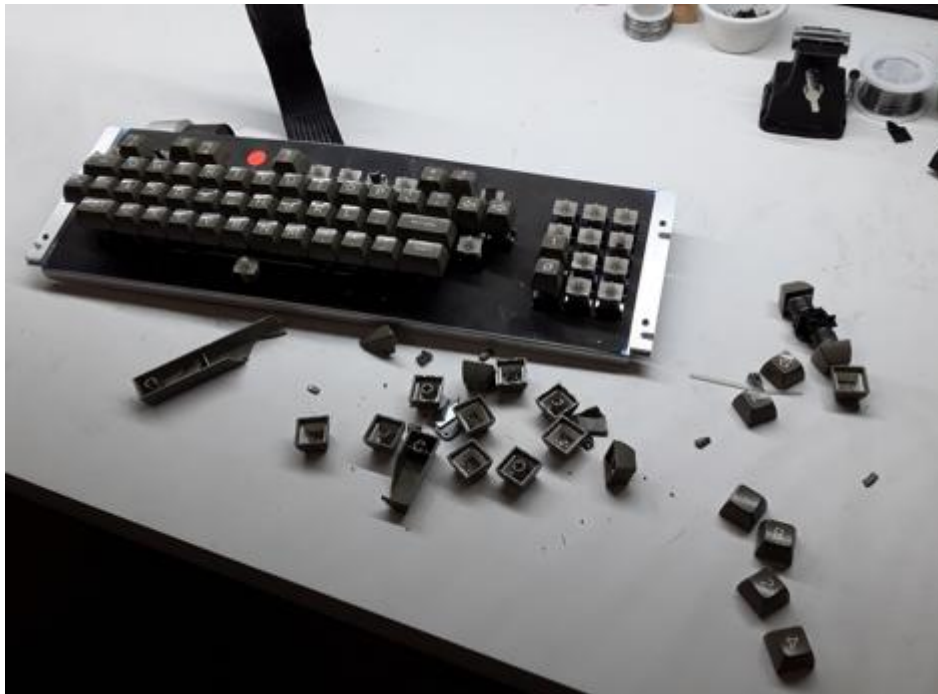
As I was moving the Osborne computer from the desk so that I could focus on the keyboard, **disaster** struck! The Osborne power cord hooked onto the keyboard cable and dragged the keyboard off the edge of the desk, and sent it crashing onto the ground.

As it was falling, my mind was thinking “oh, it’s only a short fall onto a rubber mat, it should be OK.” But then it hit the ground and about twenty of the keys smashed to bits! I was heartbroken.

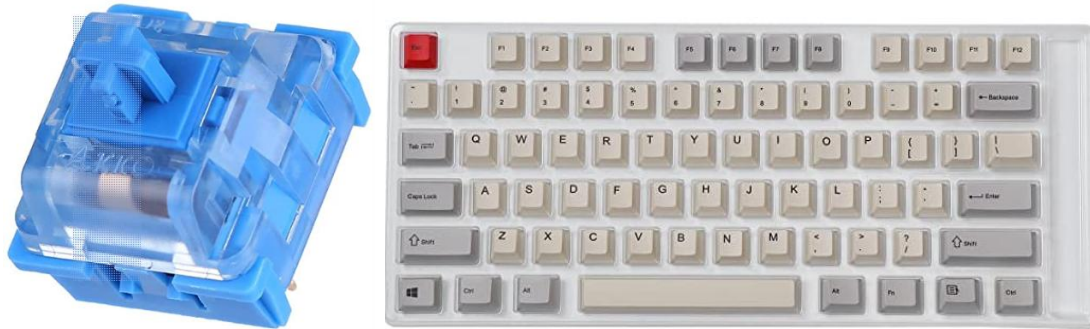
I painstakingly measured the old Osborne keyboard and laid out a new PCB using EPOMAKER AKKO CS Custom Series Tactile Ocean Blue mechanical switches along with EPOMAKER Retro Gray Cherry Profile PBT Dye Sublimation Keycaps.

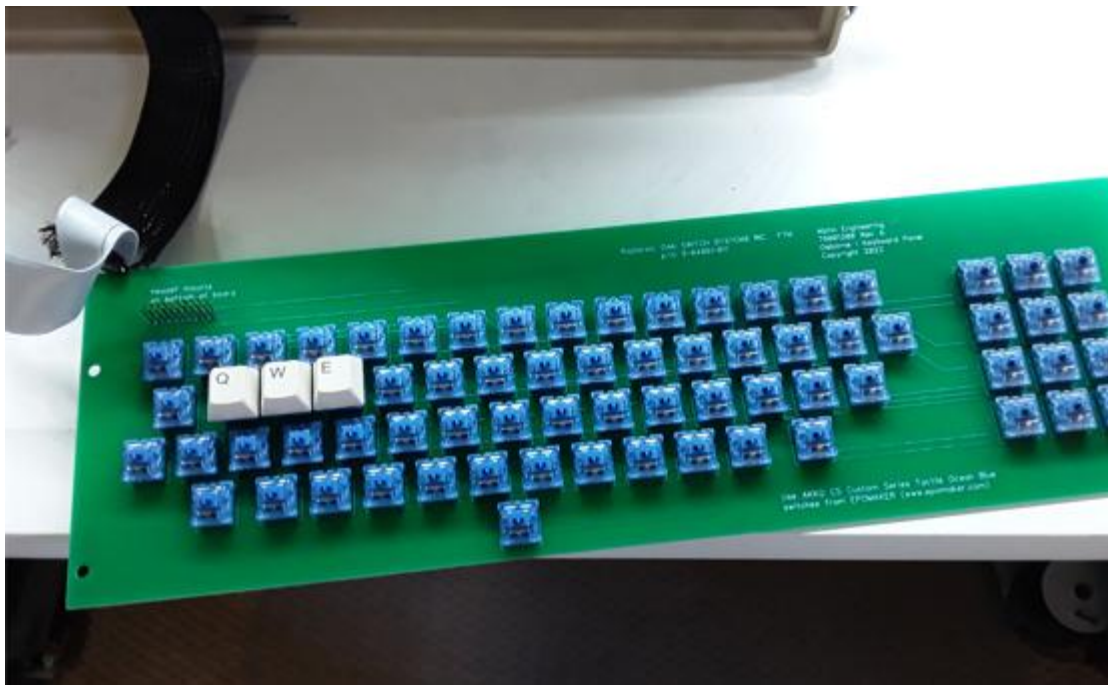
The keyboard can be seen below with a few of the keycaps installed.

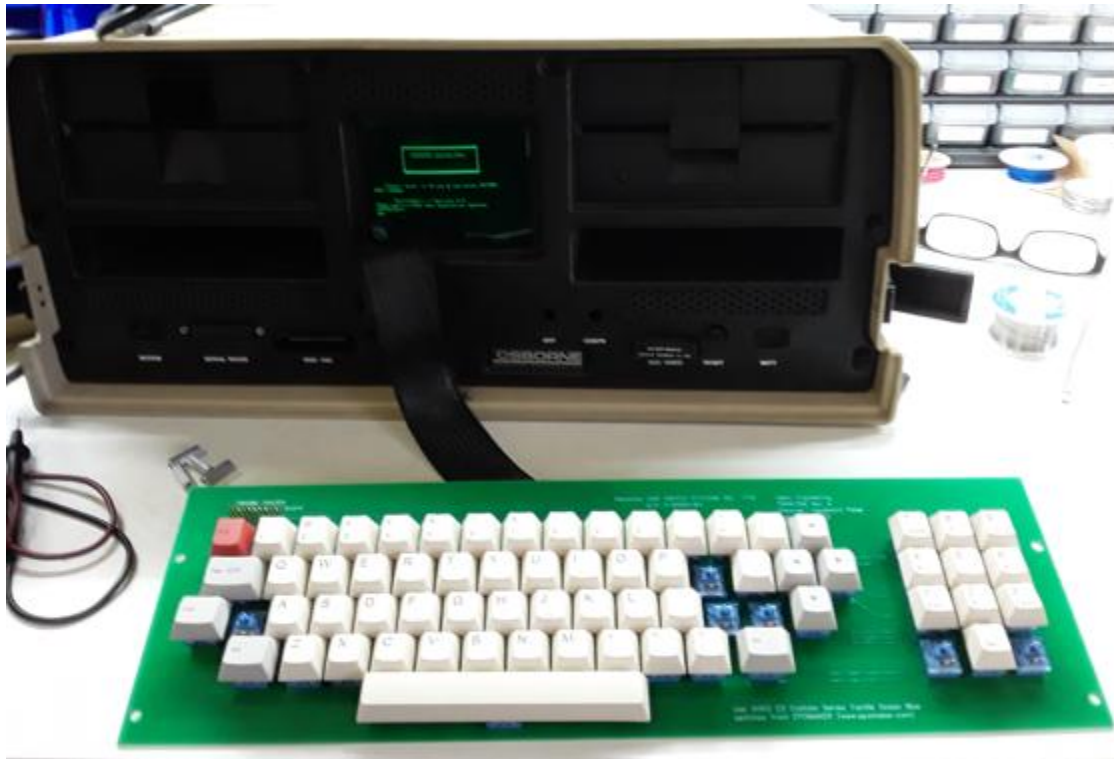
Most of the keys were a drop in as can be seen below, however several keys posed a problem.

- The 'shift' keys on modern keyboards are much larger than the Osborne 'shift' keys so I ended up using the 'alt' keycap as a 'shift' key.
- The '\`' key on modern keyboards is much larger than the Osborne '\`' key, so I arbitrarily used the ']' keycap.
- The 'numeric zero' key on modern keyboards is much larger than the Osborne 'numeric zero' key so I ended up using the 'F10' keycap.
- The 'caps lock' key on modern keyboards is much larger than the Osborne 'caps lock' key so I ended up using the 'Fn' keycap. Additionally, I didn't get a toggle switch for this so it is momentary like the rest of the keys, and really doesn't work as a caps lock.

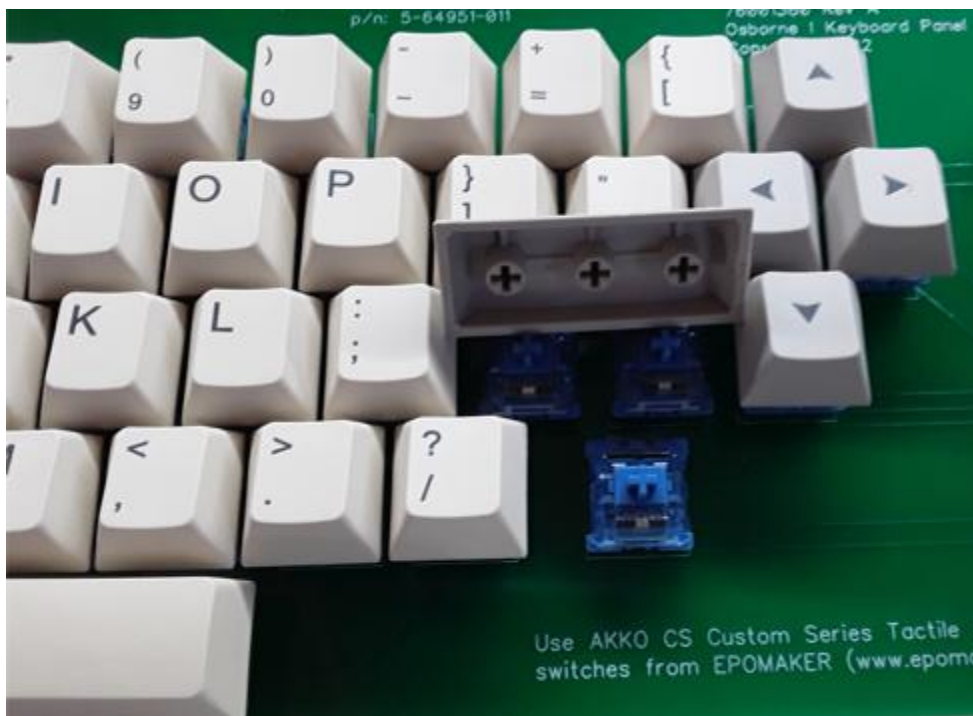
By far the biggest problem was that the 'Enter' keycap was too large to fit in the area allocated on the Osborne keyboard, AND the button mounting points were in the wrong places.

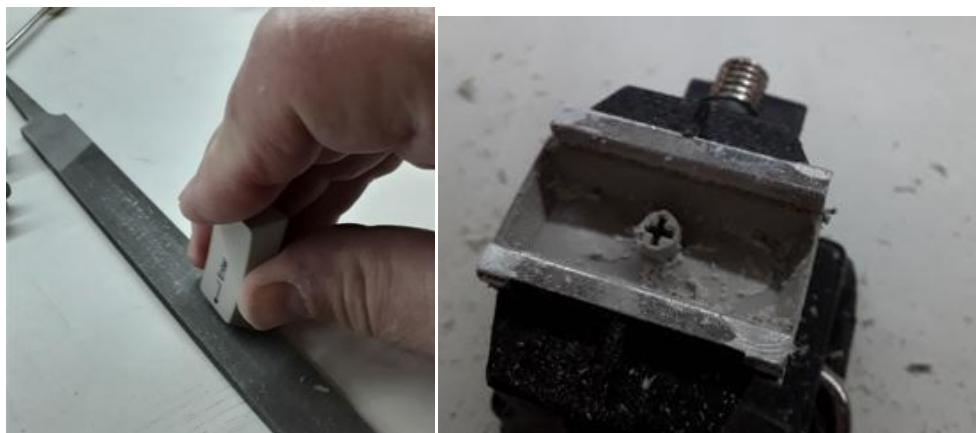
The first thing to do was to file down the 'Enter' keycap until it would fit between the other two keys. And then using a Dremel tool, remove the outside two posts of the 'Enter' keycap. The center post could stay as it passed harmlessly between the two switches.

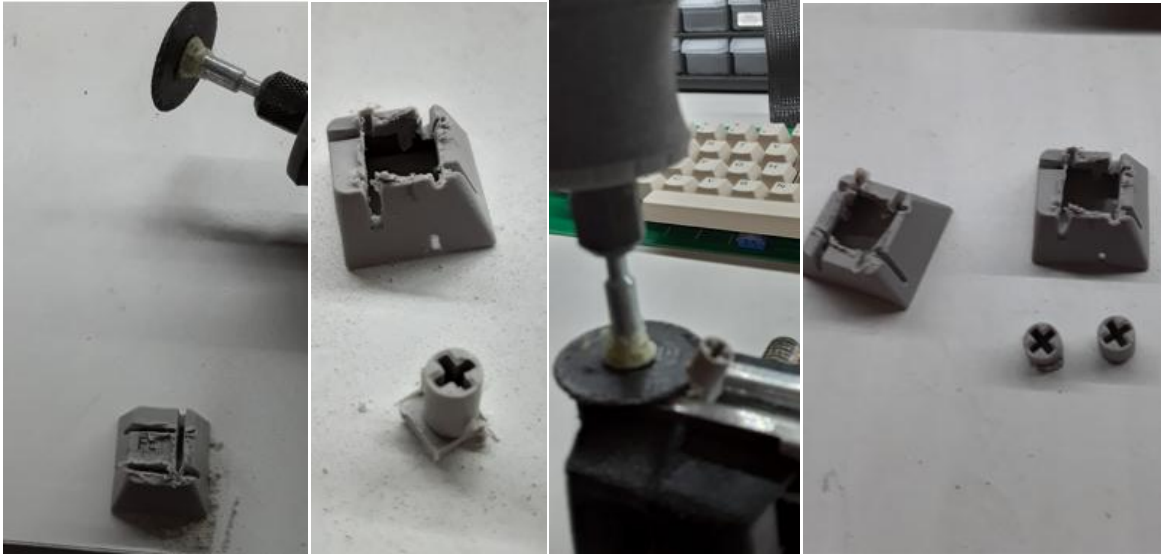
Then it was necessary to 'steal' two mounting points from other unused keycaps. This also was done using a Dremel tool.

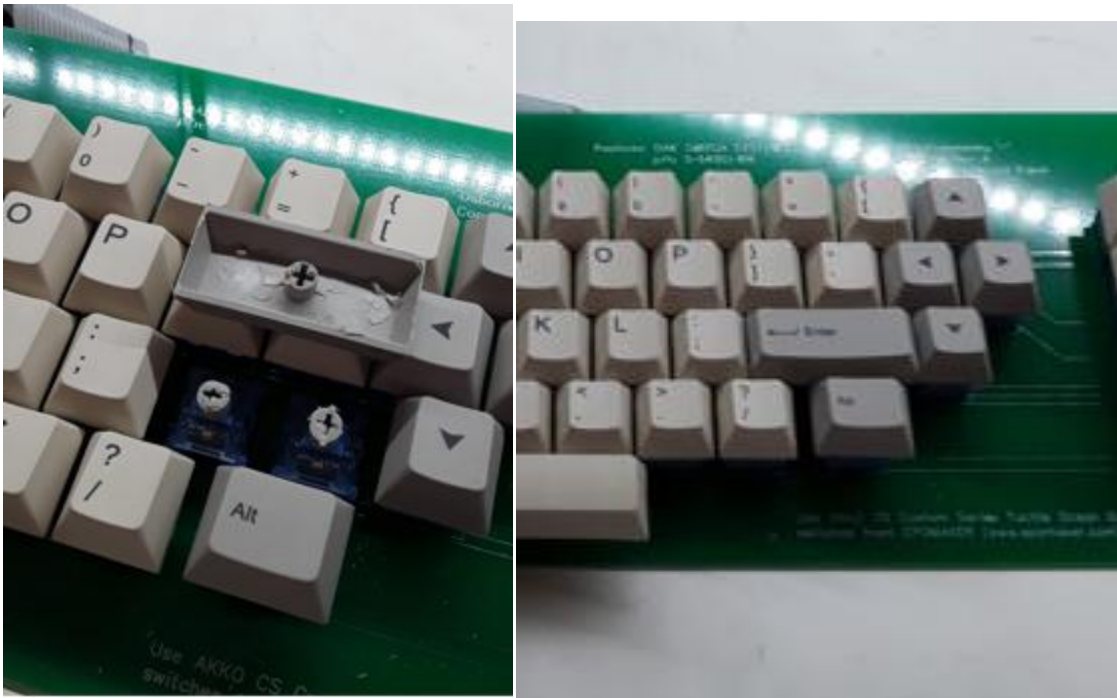
Then the two 'stolen' mounting points were placed onto the 'Enter' key switches and the modified keycap was SuperGlue'd to the top of them.

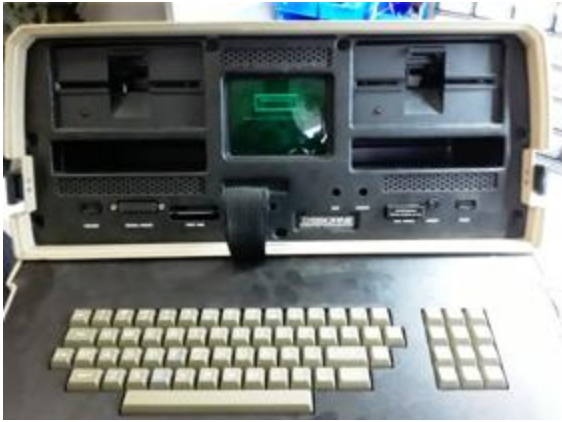
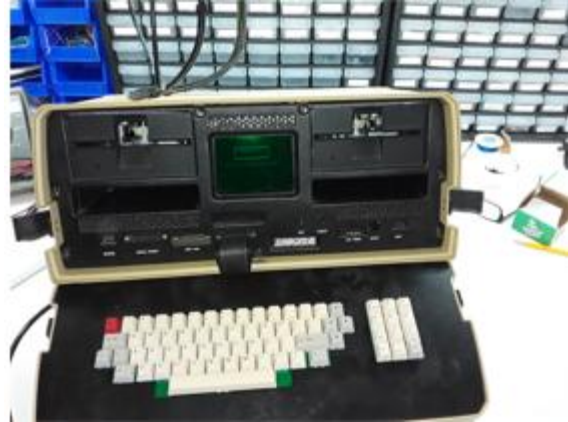
While not perfect, this (on the right below) did come out pretty close to the original (on the left below) and is far more reliable than the old worn out membrane keyboard.

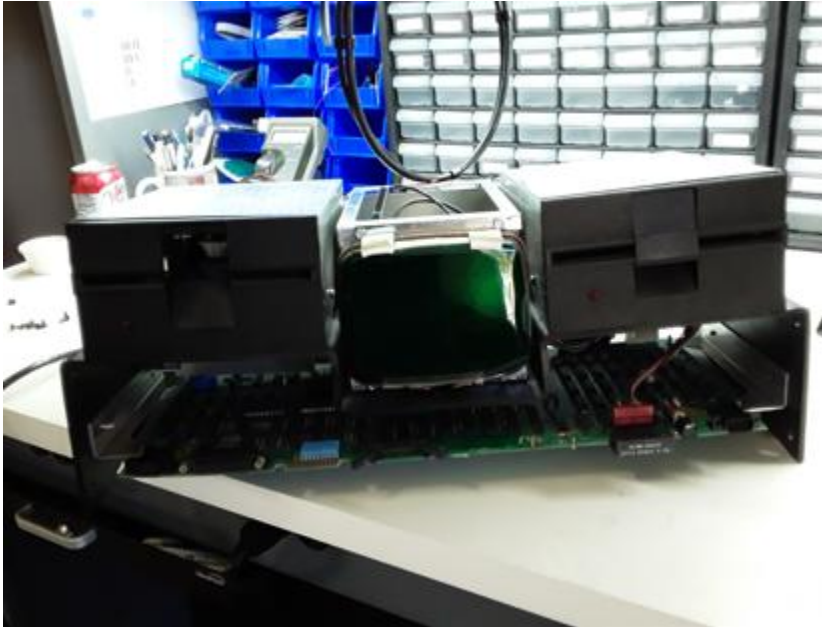
With a boot floppy inserted, hitting the 'Enter' key at the boot prompt resulted in continuous 'Boot Error' messages on the screen. I could see the floppy 'activity' LED turn on and hear the drive motor spinning, so it appeared to at least be trying to read the disk.

After taking the computer apart, it quickly became obvious what was wrong.

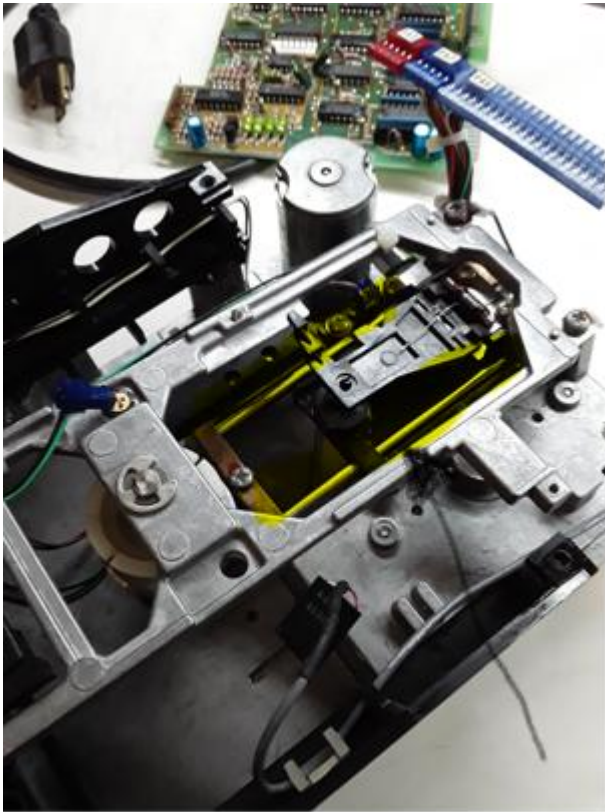
The drive head carriage was 'frozen' on the rails (see below – highlighted in yellow.) This caused the head to be unable to move from track to track and properly read the disk. This was a problem on both of the drives.

Thinking back, I remembered having a problem where the drives would 'squeak' as the head moved back in the 1980's and I think I lubricated them with cooking oil of all things, which wasn't too smart, but I think the only oil I had on hand. Doubtless this is the result of that cooking oil solidifying over the years.

After using some penetrating oil to free the carriage, I applied some light machine oil and re-assembled the unit.

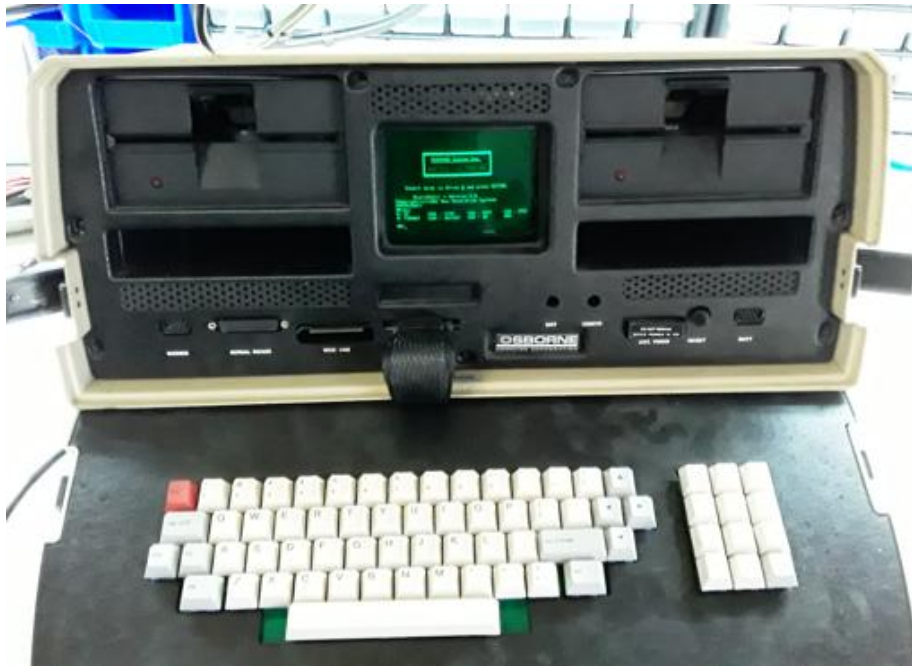
Now the unit powers on AND properly boots from the floppy drive loading the CP/M operating system.

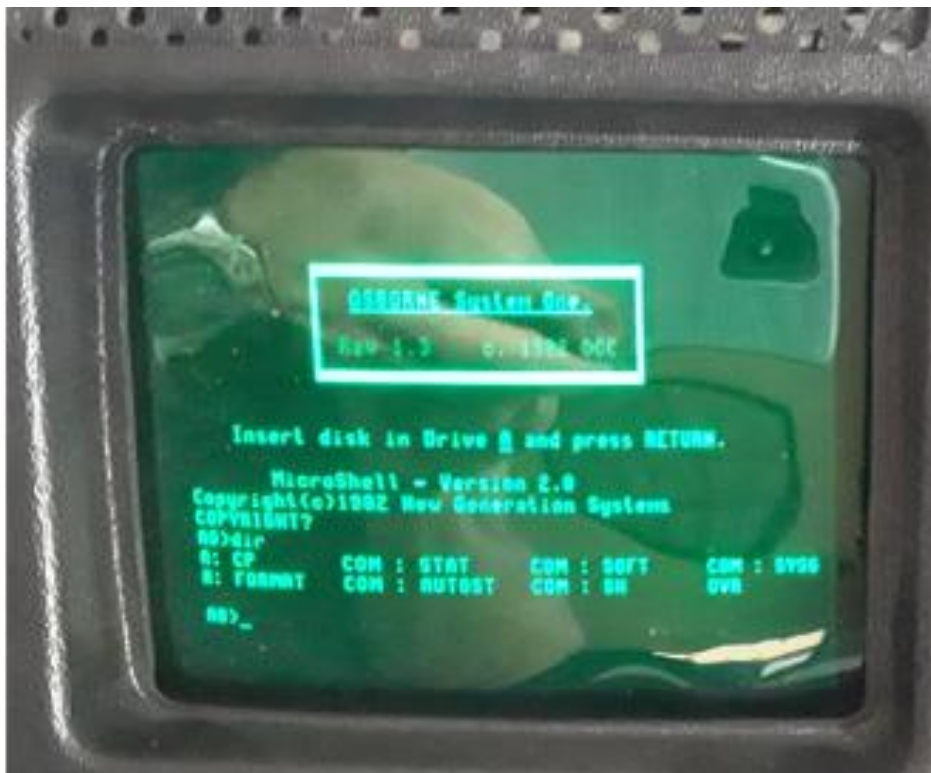
Here's a screen close-up for those of you who are nostalgic about CP/M.
