8080 Project

7601900 Board

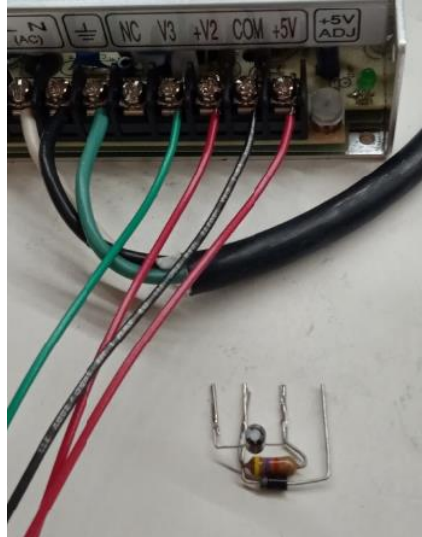
Another dilemma was that the 8080 uses 3 power supplies (+12, +5, -5) that have [strict rules](#) about how they transition at power up/down. I built up a small circuit that I could attach to the power supply rails to enforce these transitions (see below), but as it turned out it didn't seem necessary as the 8080 turned out to be more robust than advertised.

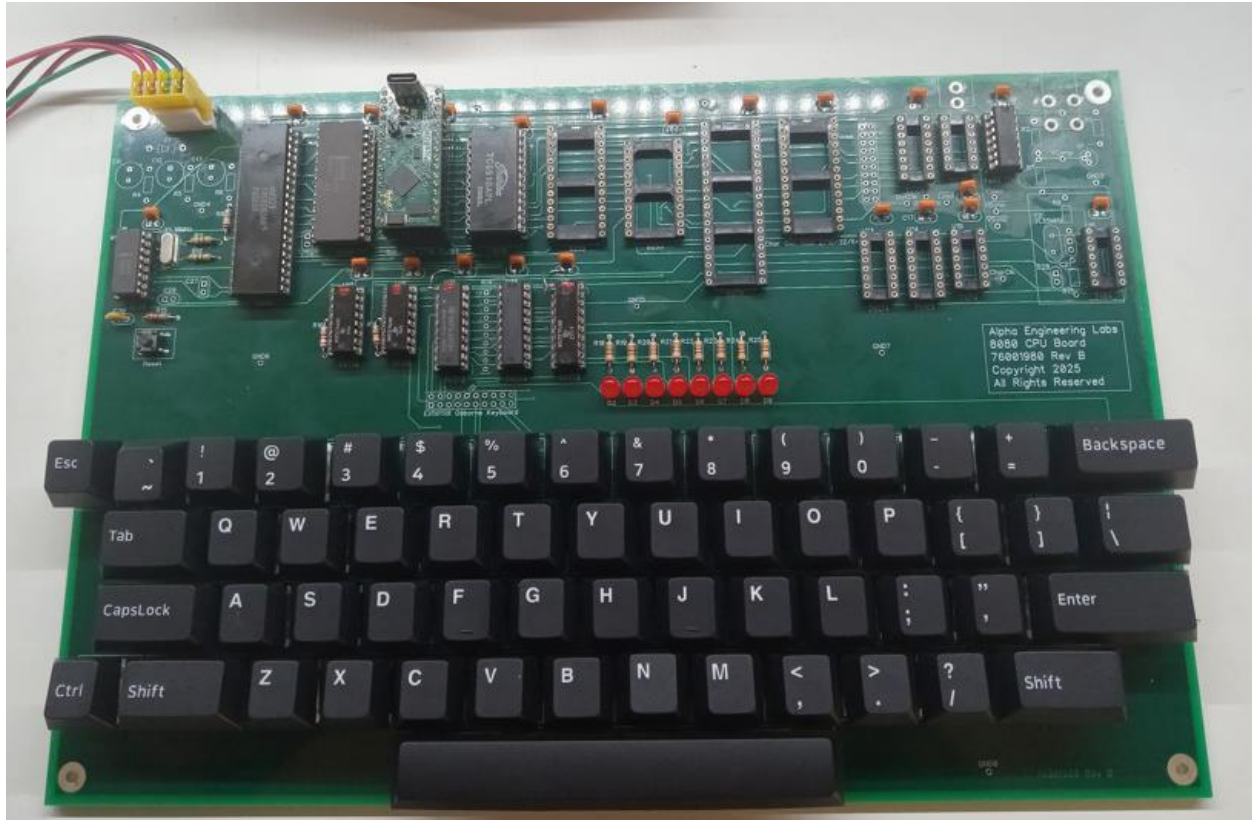
When I finally got the rev B PCB (it took longer than usual – I think NEXT PCB dropped the ball on this one) I started putting it together and ran into more issues. The good news, of course, was that the keys now fit in the keyboard!

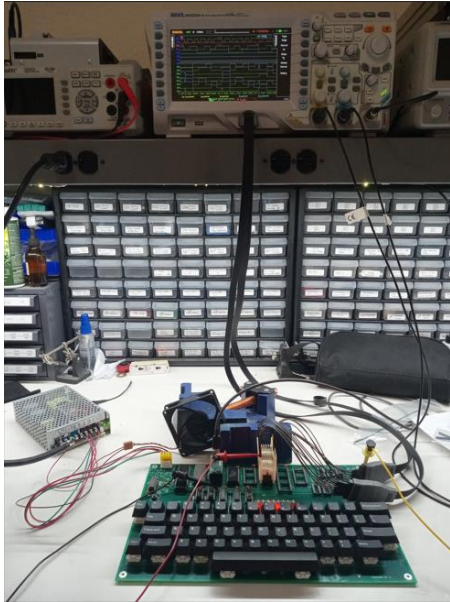
8253 PIT Timer

After spending a couple of hours, I was able to get the PIT timer chip working. I realized that I'd forgotten to add pull-ups on the three gate lines (none of the timers would work without them.)

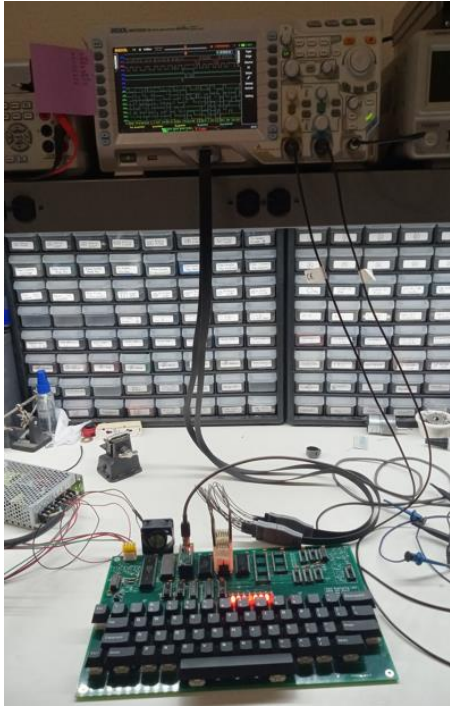
8259 Interrupt Controller

This was mostly due to my not paying attention to the fact that the interrupt vector table needed to be aligned on a 32/64 byte boundary (depending on whether the vectors were 4 or 8 byte long).

The other issue I had was that I was looking for the RETI (return from interrupt) instruction, but this is not supported in the 8080. I used the RET instruction, but it took me a while to remember that you have to manually enable interrupts (EI) before returning – so the interrupts were just hanging for a while.

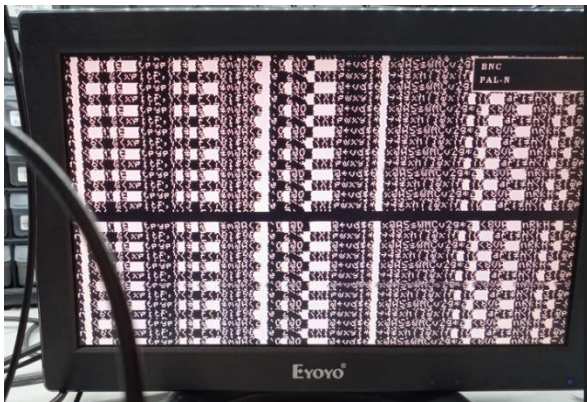
However, the data presented was total garbage – I had filled the display buffer with a repeating alphabet string.

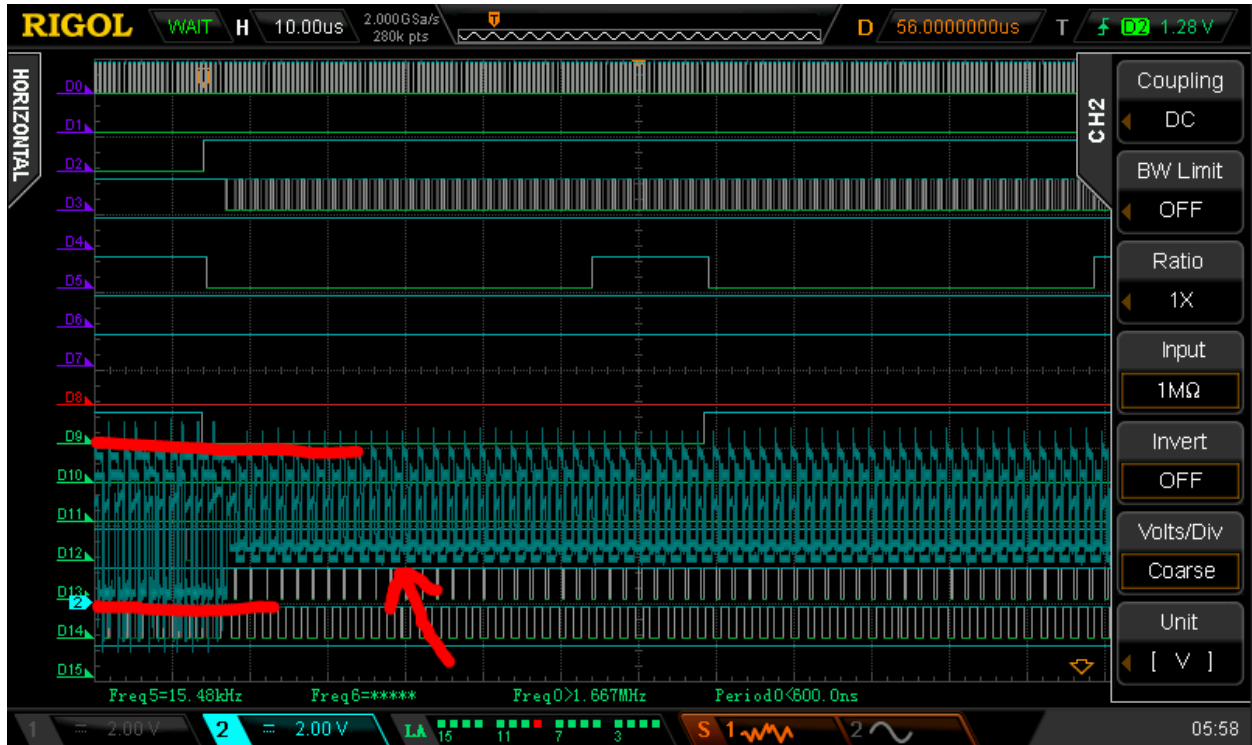
Another problem I encountered really makes no sense to me. I was seeing the RD/WR control lines not going to rails – like there was bus contention during the DMA cycles. This turned out to be a requirement that you connect the 8080 HLDA (hold ack) line to the 8228 system controller BUSEN (bus enable) so that the 8228 would tri-state the bus control lines. The confusing part for me, still, is that HLDA is already connected to the 8228 – so why doesn't it do this automatically? I thought for a moment that it could be for cases when the DMA was positioned between the 8080 and 8228 (and thus was using the 8228 lines) but that didn't make sense either because the DMA chip generates its own I/OR, I/OW, MEMR, MEMW lines. So, I'm still confused, but it works now.

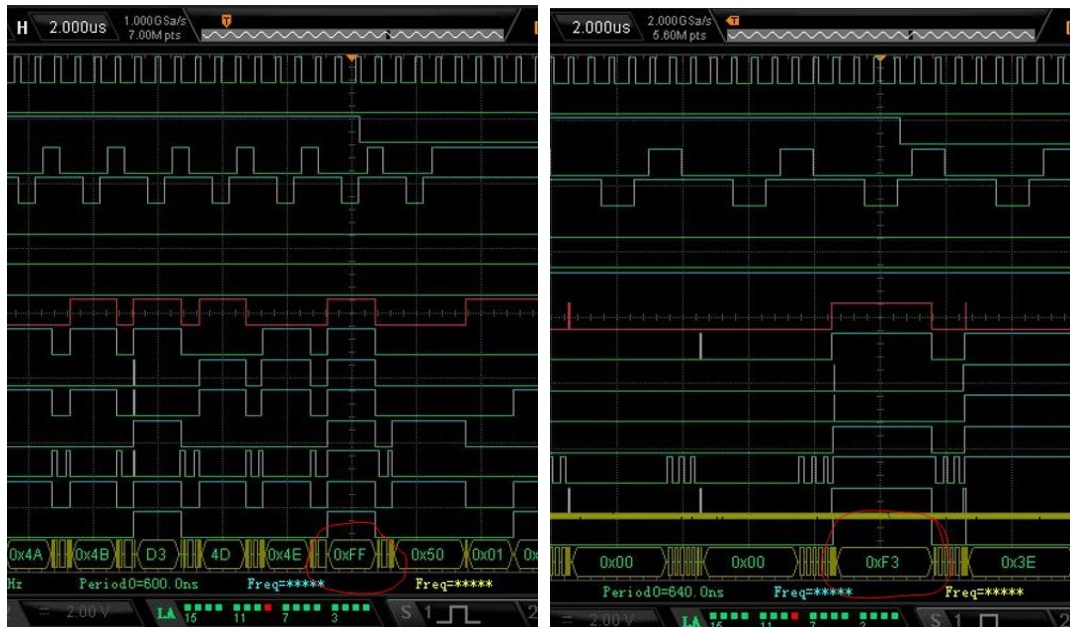
Reducing DMA Clock to Widen Read Window

I then changed the DMA to use the 2MHz system clock / 2 (by running it through the 8253 Timer chip.) Interestingly, even though this relaxed the memory read timing requirements by 100%, the exact same issue still exists. See below left for issue with 2MHz DMA clock, and right for issue with 1MHz DMA clock. Since doubling the read time didn't fix it, it doesn't appear to be a simple read timing issue.

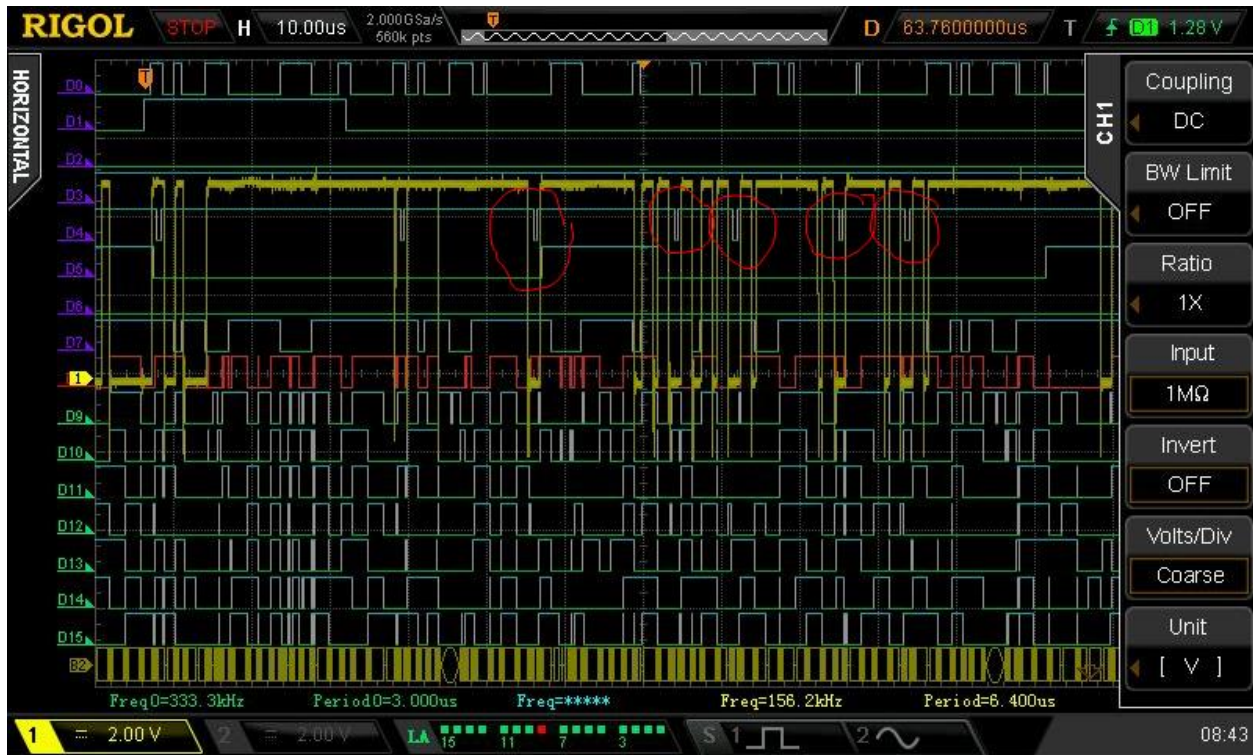
I was able to verify that the video interrupt logic is working properly (see below – yellow scope line is DMA chip select and red circled pulses are IOWR active with DMA CS.) You will have to take my word but if you expand the view, you will see that the data written out in these 5 writes is: 0x01, 0x06, 0x20, 0x7f, 0x87.

So the issue does not appear to be due to improper DMA setup.

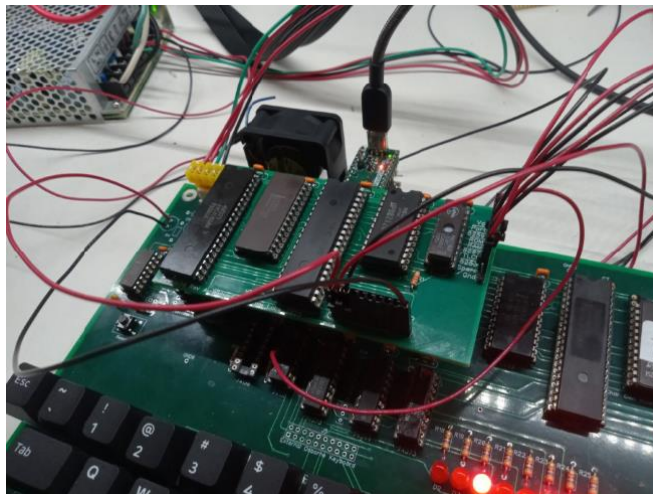
This DRASTICALLY improved the board reliability and reduced my frustration level. See improved board stability below.

- a. This gave me much more flexibility to modify chip select qualifiers.
 - b. I ended up adding AEN (active during DMA xfers when DMA has bus) to disable non-RAM chip selects from floating bus conditions, among other things.

4. Updated all prototype changes into new 760019xx schematic and PCB layouts so I am ready to get new boards made when needed.
5. Ordered more DIP socket clips for future so it is easier to do tests on multiple chips.

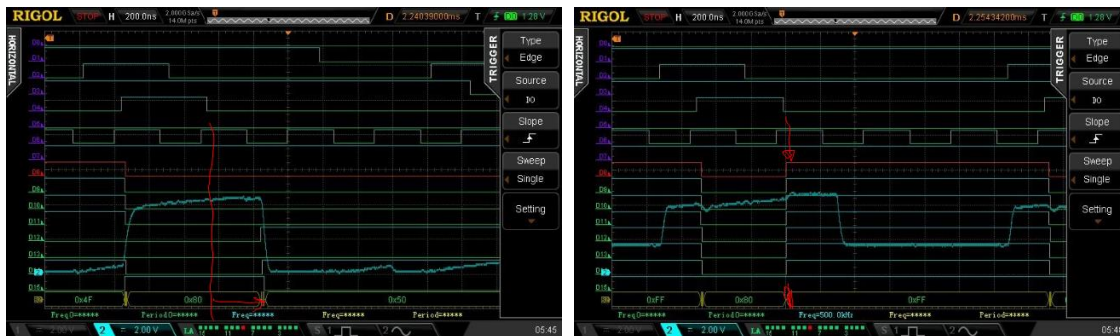
I had seen this for some time, but I was preoccupied trying to see what was different about the two cases. One thing that seemed likely was that the data was held longer after ASTB (D4) in the working case (left below) than the failed case (right below.)

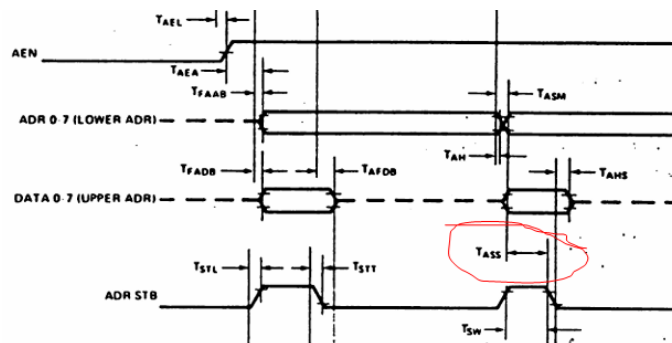
However, when you dig deeper, you will see that the DMA spec guarantees that the LSB address bus data will be stable on D0-D7 Tass (>100nS) before the FALLING edge of ASTB.

So, if the ASTB pulse is greater than T_{ass} (100nS) the data latched into the 8212 will be wrong!

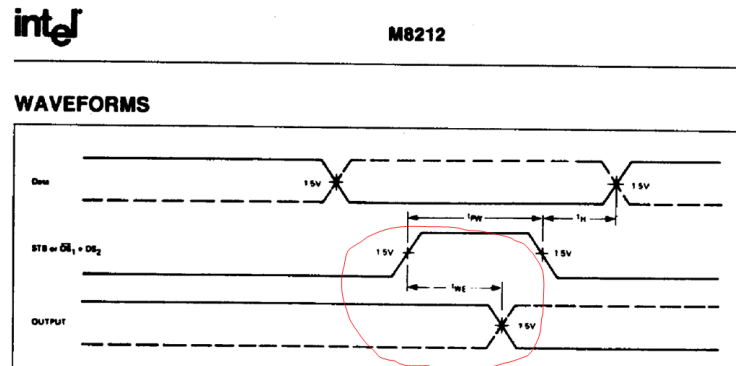
Whereas, the 8212 spec shows that the data bus inputs are transferred to the address outputs within T_{we} (<50nS) after the RISING edge of ASTB.
