Window Heat Issues

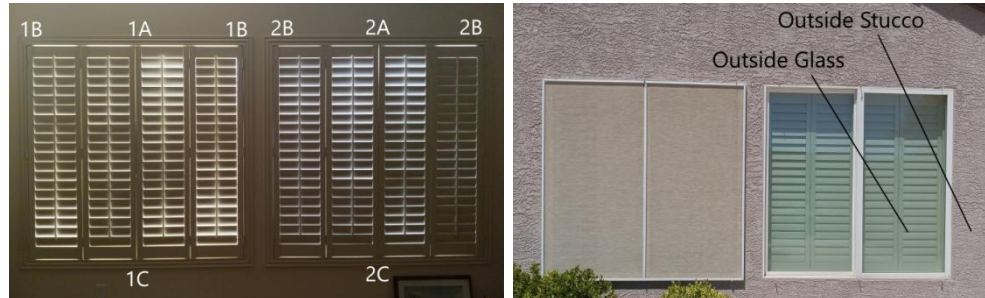
Test #1 – Solar Screen vs. No Solar Screen

7/3/2022	1A	1B	1C	2A	2B	2C	Outside Stucco	Outside Glass	Outside Temp
9am	93	92	?	?	?	?	?	?	93
10am	94	92	78	85	83	76	146	119	95
11am	90	90	78	85	83	77	140	115	96
12pm	86	86	77	82	81	76	126	108	97
1pm	85	85	76	81	81	76	113	101	98

This table illustrates a critical (and often non-intuitive) point that the peak material (stucco, glass, etc.) temperature does NOT occur with the peak outside air temperature, but rather when the sun’s rays are directly beating down on the surfaces. For vertical walls this is when the sun is still lower in the sky.

As can also be seen from this table, the peak inside temperature occurs at 10am in the window with no solar screen. The window with a solar screen is 9 degree cooler. The difference from room temperature (74F) is 11F for the window WITH a screen, and 20F for the window WITHOUT a screen. Therefore the solar screen is providing about an 82% cooling benefit (over no solar screen and relative to the room temperature.) This is a relative percentage measure and doesn’t prove if the screen is fully functional or not, but it does show that there is a clear benefit to using the screen – even though it is old.

What is alarming about this data is that, at 10am, the inside window temperature (without a solar screen) is only 1 degree cooler than the outside temperature! It’s as though the window doesn’t even exist. Clearly there must be something else in play here as the windows are high quality double pane construction and would be expected to do a better job keeping the heat out.

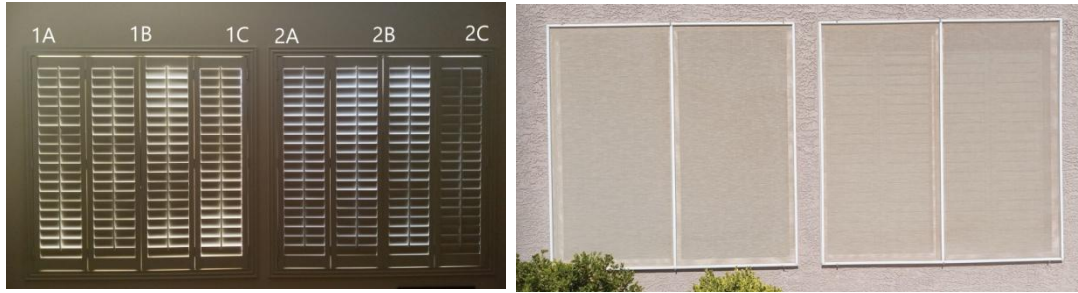
Test #1 – Solar Screen AND UV Film

7/8/2022	1A	1B	1C	2A	2B	2C	1->2 Delta	Outside Temp
8:52am	88	84	85	86	88	84	+1	98
10:10am	89	85	86	86	89	84	-1	100
11:11am	88	84	84	84	87	83	-2	102
12:40pm	84	82	81	80	83	81	-3	101
1:25pm	84	82	83	81	83	81	-4	100
2:17pm	83	82	82	81	82	80	-3	101
3:00pm	82	81	81	80	81	79	-4	?

The surprising observation here is that, although the outside edges (A & C) of the UV film window are a degree or two cooler, the center of the UV film window is 1-4 degrees hotter!

This was very perplexing as I was expecting the UV film window to be noticeably cooler than the window without UV film.

After thinking about it for a while, the only conclusion that made any sense was that the solar screen (contrary to previous thinking) was actually doing a good job and blocking most of the UV from entering the window. If this were true then there would be no benefit to adding the UV film – because there wouldn't be any UV left to block.

Then the additional heat could be explained by the fact that the UV film might have added an additional infrared (IR) barrier that reflected some of the trapped heat back into the room that would otherwise have gone outside through the window.

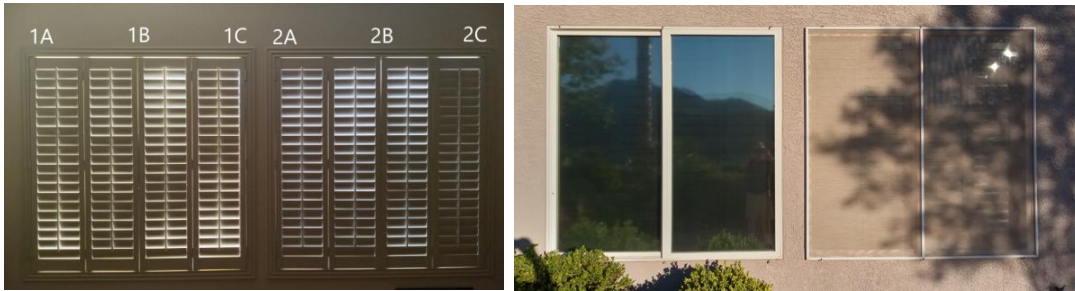
Test #2 – UV Film Without Solar Screen

7/9/2022	1A	1B	1C	2A*	2B	2C	1->2 Delta	Outside Temp
6:30am	75	76	75	79	78	78	+9	85
7:26am	80	81	80	91	92	87	+29	90
8:29am	87	87	85	97	97	91	+26	97
9:18am	88	88	87	96	98	91	+21	100

This roughly 10 degree hotter trend on the window without the solar screen closely follows the [previous test](#) that was done without a solar screen or UV film.

It should be noted that the UV film is providing some benefit (about 50% of the solar screen benefit) at the edges of the window, but almost no benefit at the center of the window. So overall the UV film would be providing roughly 25% of the benefit provided by the solar screens.

This would indicate that the UV film is providing little benefit (compared to solar screens) in blocking the sun's infrared heat from entering the house. The film may be blocking UV (which can damage fabrics) but from the point of view of reducing infrared heat to reduce AC usage, the UV film does not appear to provide anywhere near the benefit of good solar screens.

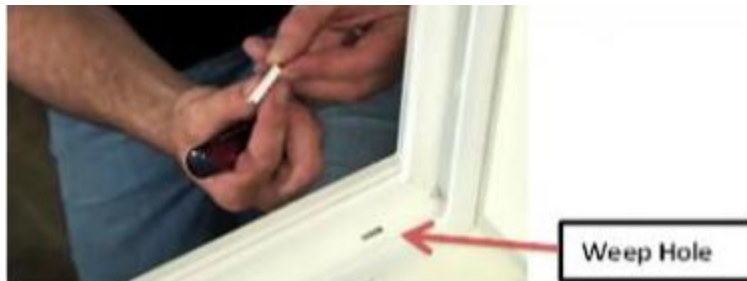
Defective Caulking

IMPORTANT – I later realized that this hole is a functional part of the window and should **NOT** be blocked. All of the windows have this hole and it is referred to as a “weep hole.” For more information see: [How To: Test the Weep System on Your Milgard® Vinyl Windows and Doors | Milgard](#)

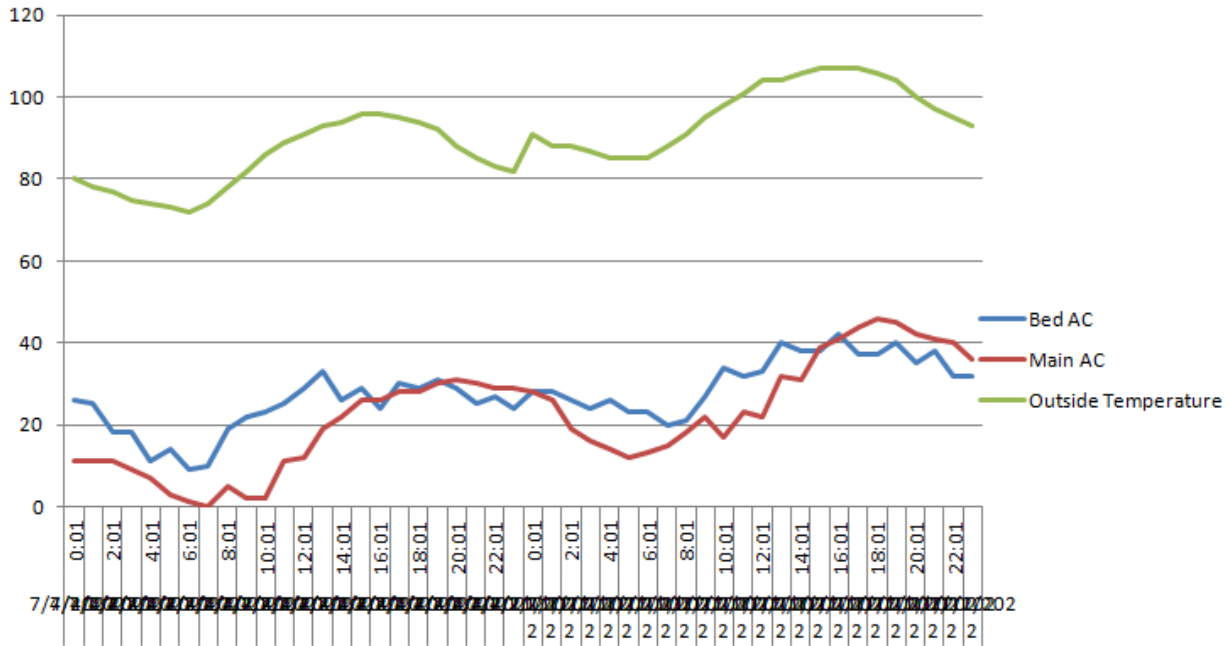
AC Usage Changes

1. 7/4/2022 (on the left) before the window heat issues were addressed.
2. 7/11/2022 (on the right) after the window heat issues were addressed (ScotchGard applied to solar screens.)

Although the second day was considerably hotter, the important thing to note here is that the Bed AC (blue) and Main AC (red) lines are now closer together showing that the morning heat issues in the Bed area have been mitigated to some extent.

Note also that on the first day the bed AC barely ever dips below the main AC, whereas on the second day the bed AC clearly dips below the main AC in the afternoon. This is what is expected as the bed AC has to work against the morning sun, whereas the main AC has to work against the afternoon sun.

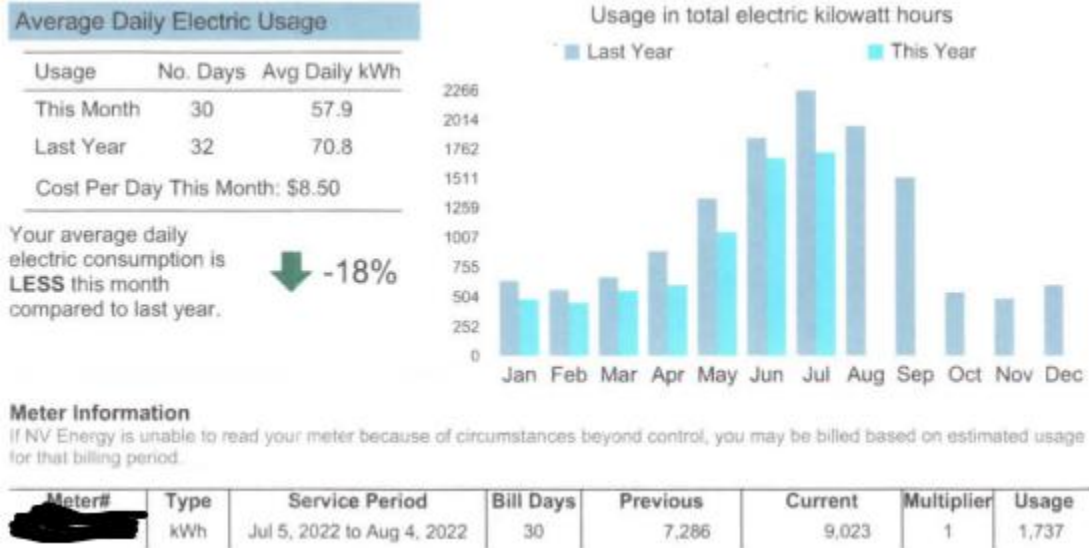
Power Savings

I had initially expected this to result in noticeably lower power bills, but the initial bill is not showing significant savings. As can be seen in the graph below July 5-August 4 (changes were made July 10) shows an 18% reduction in power from last year.

However, it is also obvious that all previous months also had approximately the same reduction as well. This 18% reduction is due to the fact that the air circulator feature was turned off (see [Air Circulator Savings.](#))

While there are many other factors that can affect this crude comparison (year to year temperature differences, other electrical usage, etc...) it is clear that simply applying ScotchGard to existing solar screens did not “dramatically” reduce power usage. However it did clearly have an effect on AC operation as it balanced the dual AC systems to operate equally.
